American Property Inspectors

Home Inspection

1111 Old School House Rd
Somewhere, FL

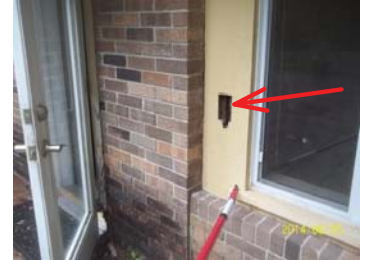
1. Type: Brick veneer/Wood Hole in rear wall from removed electrical outlet, suggest repair.

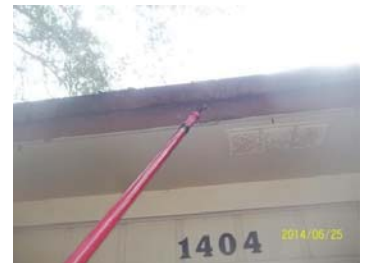
3. Fascia: Wood Wood rot in fascia at front of garage, suggest repair.

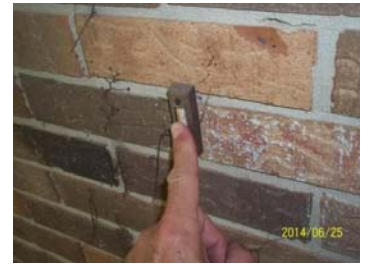
5. Door Bell: Hard wired Doorbell did not chime when activated, suggest repair/replacement.

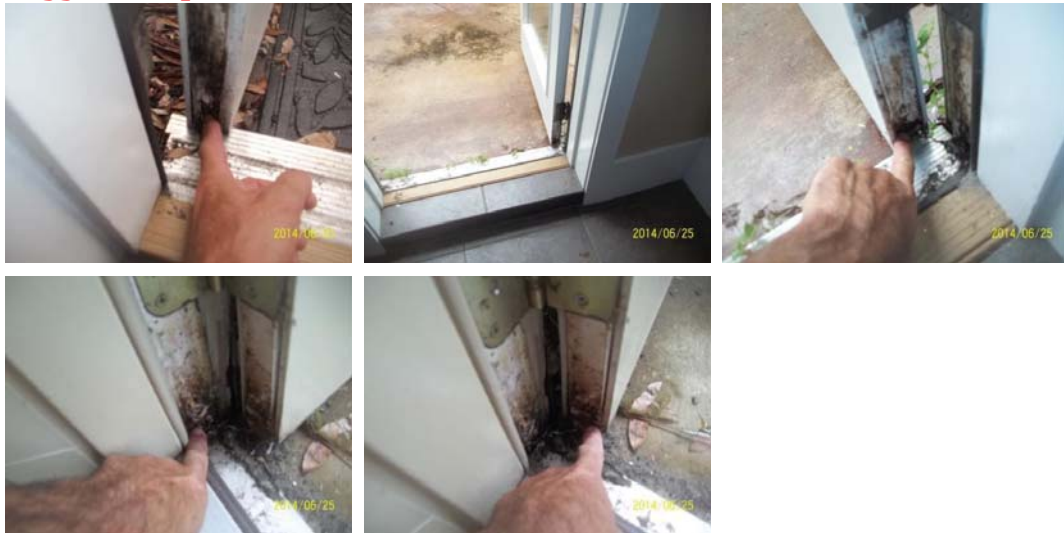
7. Patio Door: Vinyl/Glass Wood rot a the wooden core of all patio doors, suggest repair.

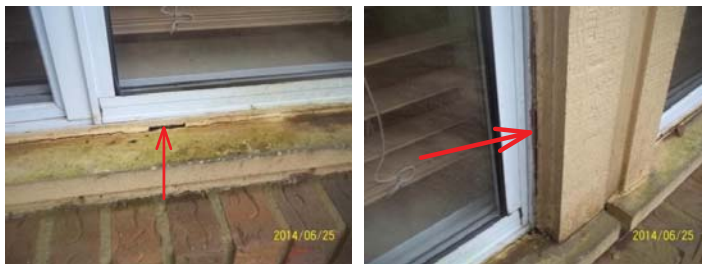
8. Windows: Metal Single/Double hung Sealant separation at window frames, suggest re-sealing during routine maintenance. This applies to all windows.

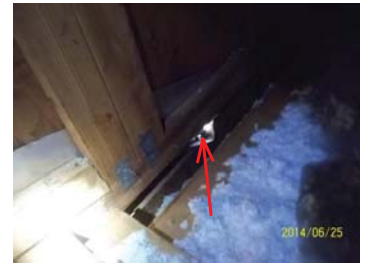
5. Flashing: Metal Flashing at right side front inadequate. Light can be seen from the attic at the kick-out flashing at the bottom of the right front rake. This indicates that water may enter the structure at this location, suggest further evaluation and repair by licensed roofing contractor.

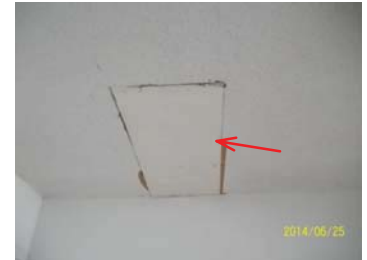
1. Type of Structure: Attached Car Spaces: 2
2. Garage Doors: Braced, Insulated Aluminum with Glazing
3. Door Operation: Mechanized
4. Door Opener: Lift Master
5. Service Doors: Metal
6. Ceiling: Sheetrock-Paint **Incomplete patch at ceiling, suggest repair.**

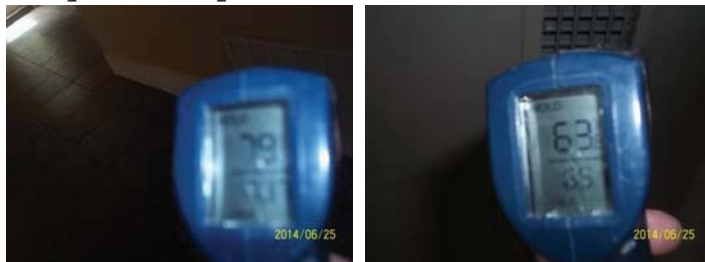
1. A/C System Operation: Functional at time of inspection System produced adequate temperature differential of 16 degrees.

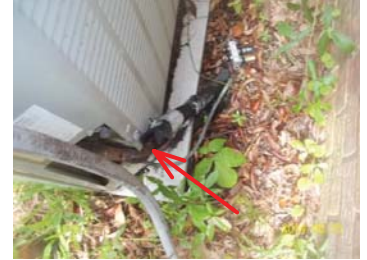
8. Type: Central A/C Capacity: 2 Ton
9. Visible Coil: Aluminum
10. Refrigerant Lines: Serviceable condition
Damage/deterioration noted at refrigerant line insulation, suggest replacement during routine maintenance.

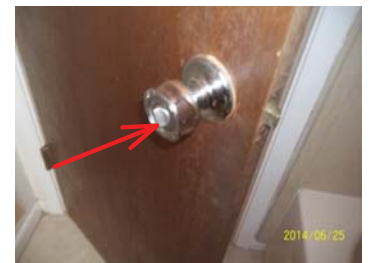
4. Doors: Standard Door lock non-functional, suggest repair/replacement.

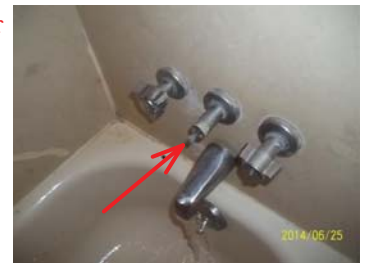
8. Sink/Basin: Molded single bowl
9. Faucets/Traps: Metal/PVC Handle not present at shower diverter, suggest replacement.

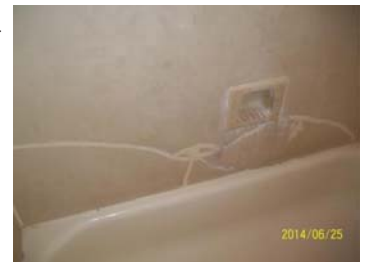
10. Tub/Surround: Fiberglass tub and fiberglass surround
Cracking in tub surround with caulking applied, suggest proper repair or replacement.

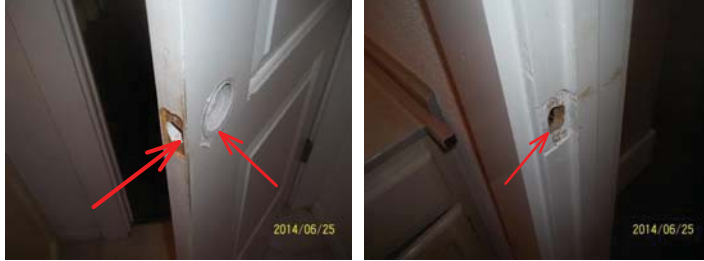
18. Doors: Standard Door hardware removed, suggest replacement.

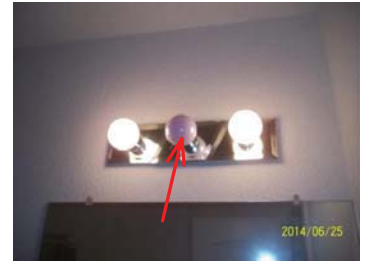
19. Electrical: 110 VAC outlets and lighting circuits Not all lights illuminated, suggest bulb replacement and re-test.

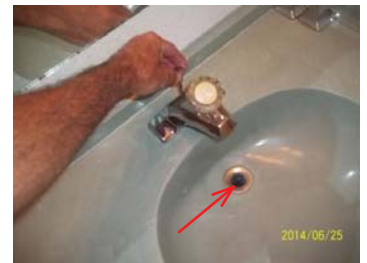
20. Counter/Cabinet: Fiberglass/Wood
21. Sink/Basin: Molded single bowl Sink stopper damaged/not present at sink, suggest repair/replacement.

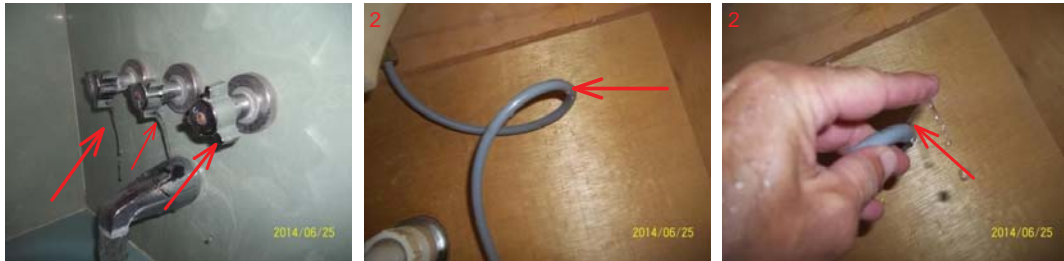
22. Faucets/Traps: Metal/PVC 1. Leak observed at all three tub faucet handles when in operation, suggest adjustment/repair.
2. Leak observed in supply line for the cold water side of sink, suggest repair. Water turned off at shut-off valve after detection.

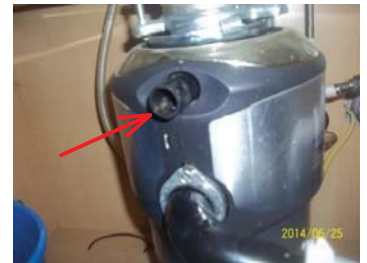
1. Cooking Appliances:
2. Ventilator:
3. Disposal: In-Sinkerator Water discharged from disposal at dishwasher drain entry, suggest replacement of drain hose and re-test.

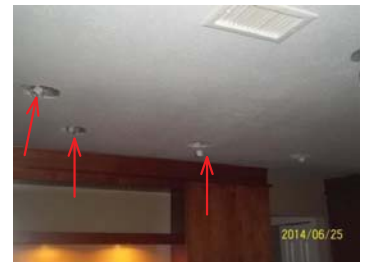
4. Dishwasher:
5. Air Gap Present? Yes No
6. Refrigerator:
7. Microwave:
8. Sink: Stainless Steel
9. Electrical: 110 VAC outlets and lighting circuits
Light fixtures removed from ceiling, suggest replacement.

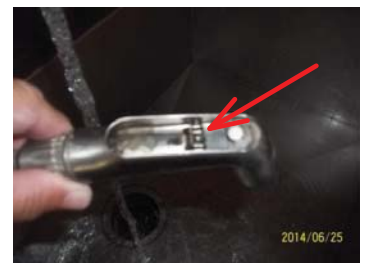
10. Plumbing/Fixtures: Metal/PVC Spray handle damaged (operation handle not present), suggest repair/replacement.

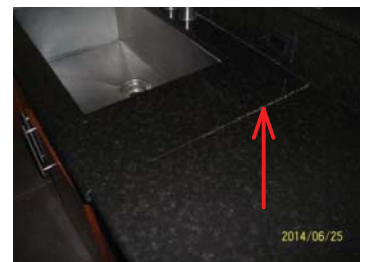
11. Counter Tops: Stone Ill-fitting and uneven seams at counter-tops, suggest adjustment/repair.

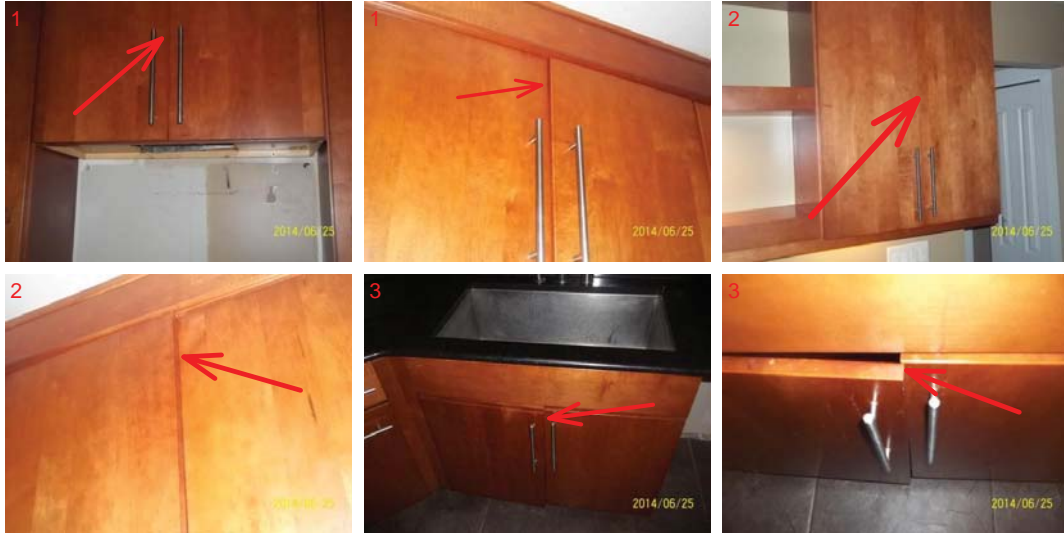
12. Cabinets: Wood 1. Cupboard doors above microwave enclosure collide when closed, suggest adjustment/repair.
2. Cupboard doors at right side collide when closed, suggest adjustment/repair.
3. Cabinet doors under sink collide when closed, suggest adjustment/repair.

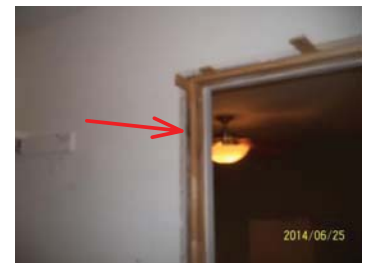
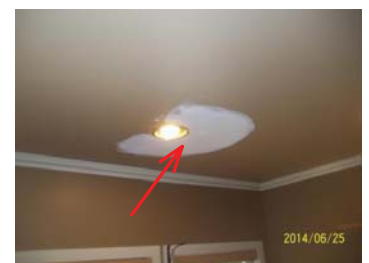
1. Closet: Walk In Trim removed from interior frame of closet door, suggest replacement.
2. Ceiling: Sheetrock-Paint Incomplete repair at ceiling of rear area of bedroom, suggest repair.

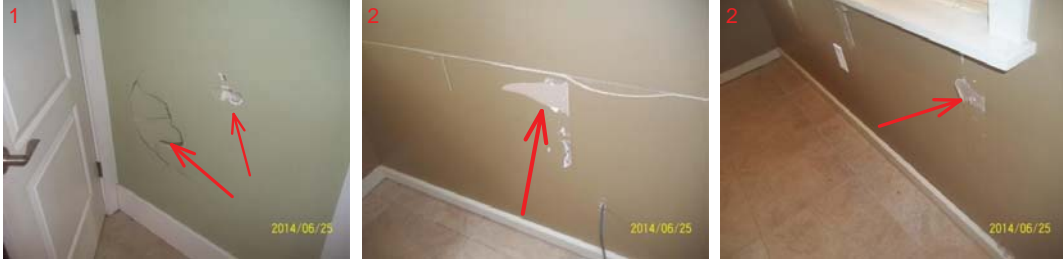
3. Walls: Sheetrock-Paint 1. Holes in wall behind door, suggest repair.
2. Peeling sheet-rock paper at rear area of bedroom, suggest repair.

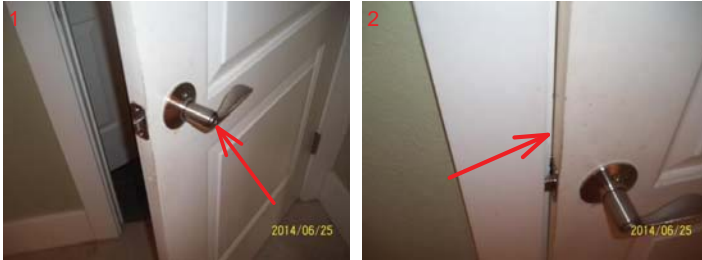
4. Floor: Tile
5. Doors: Standard 1. Door lock non-functional, suggest repair/replacement.
2. Door collides with frame at closing, suggest adjustment/repair.

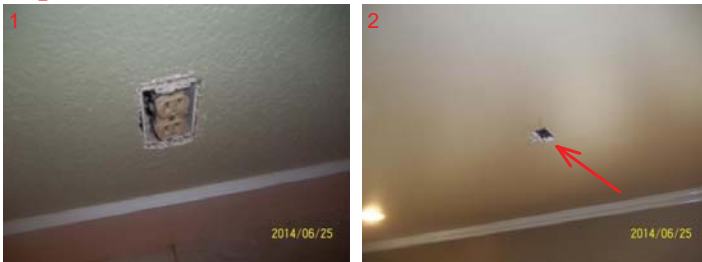
6. Windows: Metal Slider
7. Electrical: 110 VAC outlets and lighting circuits 1. Cover plate not installed at rear wall, suggest replacement.
2. Fixture removed from ceiling at rear area of bedroom, suggest replacement.

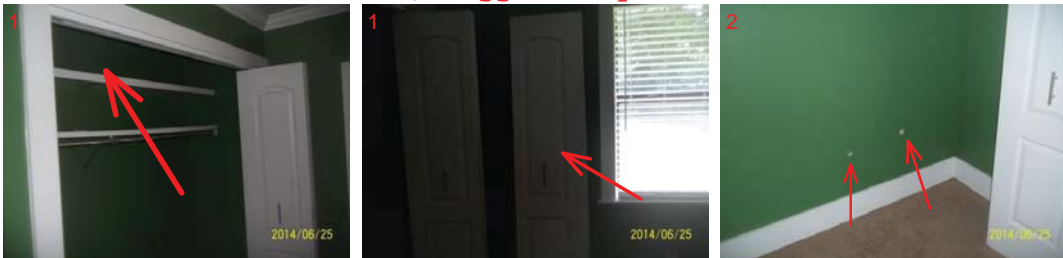
9. Closet: Single 1. Closet door removed from hardware (leaning against wall), suggest replacement.
2. Holes in closet wall, suggest repair.

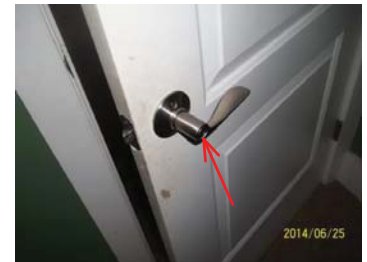
- 10. Ceiling: Sheetrock-Paint
- 11. Walls: Sheetrock-Paint
- 12. Floor: Carpet
- 13. Doors: Standard Door lock non-functional, suggest repair/replacement.

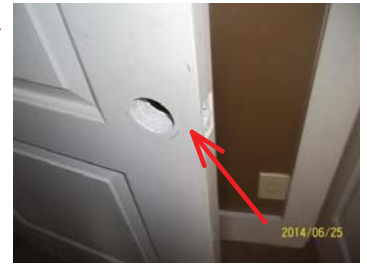
21. Doors: Standard Hardware removed from door, suggest replacement.

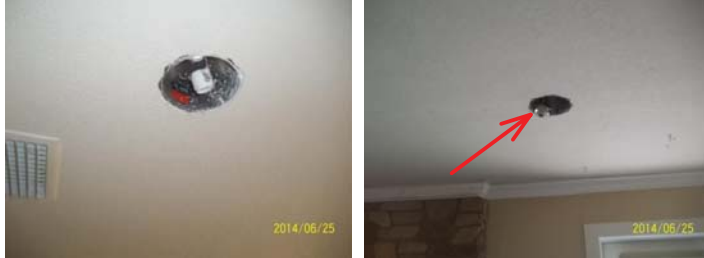
4. Electrical: 110 VAC outlets and lighting circuits **Fixtures/bulbs removed from overhead lighting, suggest replacement.**

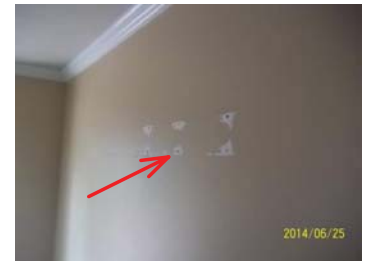
7. Walls: Sheetrock-Paint **Damage to right side wall, suggest repair.**

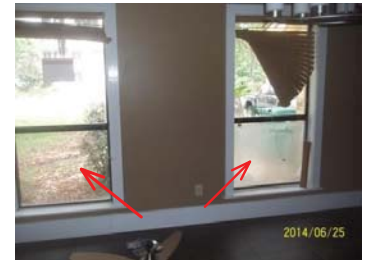
9. Windows: Metal Single/Double hung **Evidence of condensation between panes of glass indicate thermal seal is broken at both lower sashes, suggest repair/replacement.**

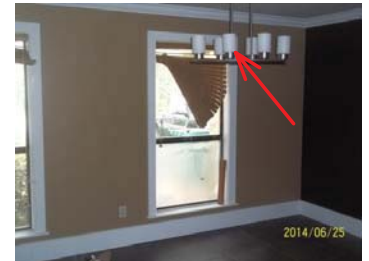
10. Electrical: 110 VAC outlets and lighting circuits **No lights illuminated, bulb replacement and re-test indicated no electricity at this fixture, suggest further evaluation by qualified technician with repair as necessary.**

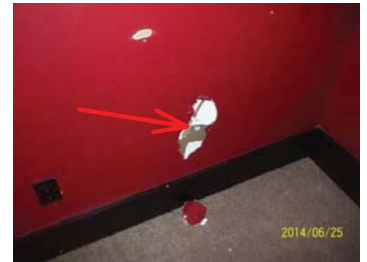
13. Walls: Sheetrock-Paint **Hole in rear wall, suggest repair.**

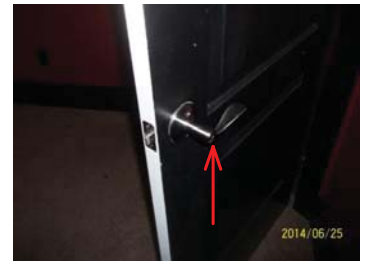
14. Floor: Carpet
15. Doors: Standard **Door lock non-functional, suggest repair/replacement.**

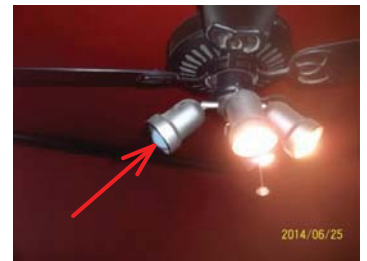
17. Electrical: 110 VAC outlets and lighting circuits **Not all lights illuminated, suggest bulb replacement and re-test.**

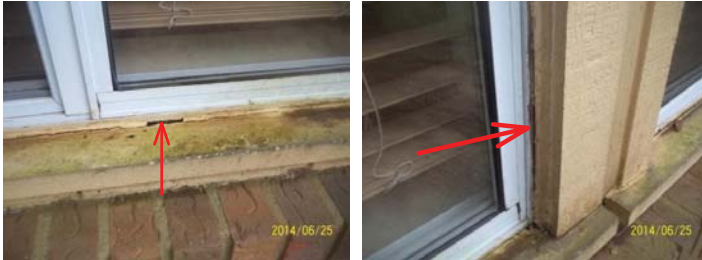
1. Windows: Metal Single/Double hung Sealant separation at window frames, suggest re-sealing during routine maintenance. This applies to all windows.

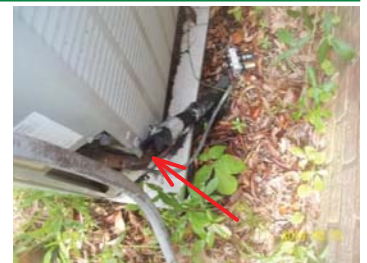
2. Right Side AC System Refrigerant Lines: Serviceable condition
Damage/deterioration noted at refrigerant line insulation, suggest replacement during routine maintenance.

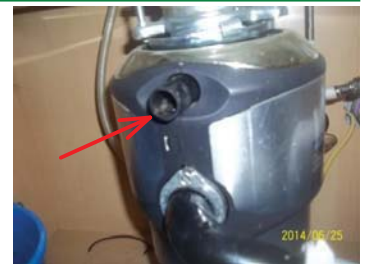
3. Main Kitchen Disposal: In-Sinkerator Water discharged from disposal at dishwasher drain entry, suggest replacement of drain hose and re-test.

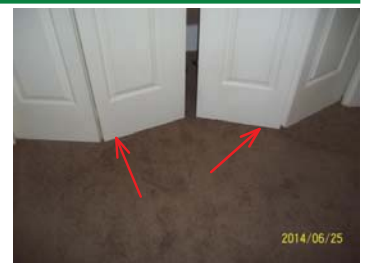
4. Right Front Bedroom Closet: Single Closet doors rub at carpet, suggest adjustment/repair during routine maintenance.

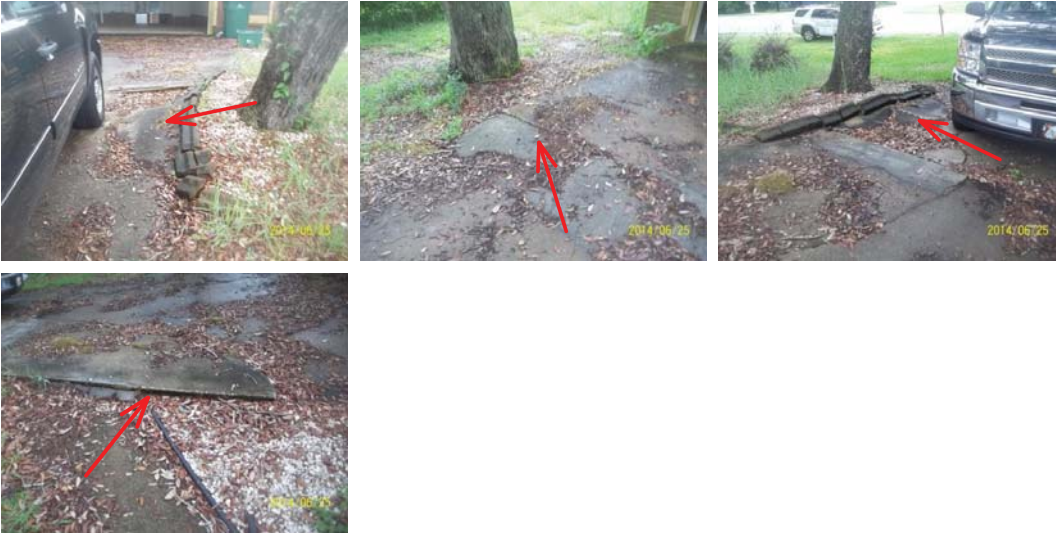
1. Driveway: Concrete Heaving and displacement noted at driveway. This is possibly caused by root growth of nearby trees, suggest further evaluation by qualified technician to determine the appropriate remedy. There is a trip hazard present at time of inspection.

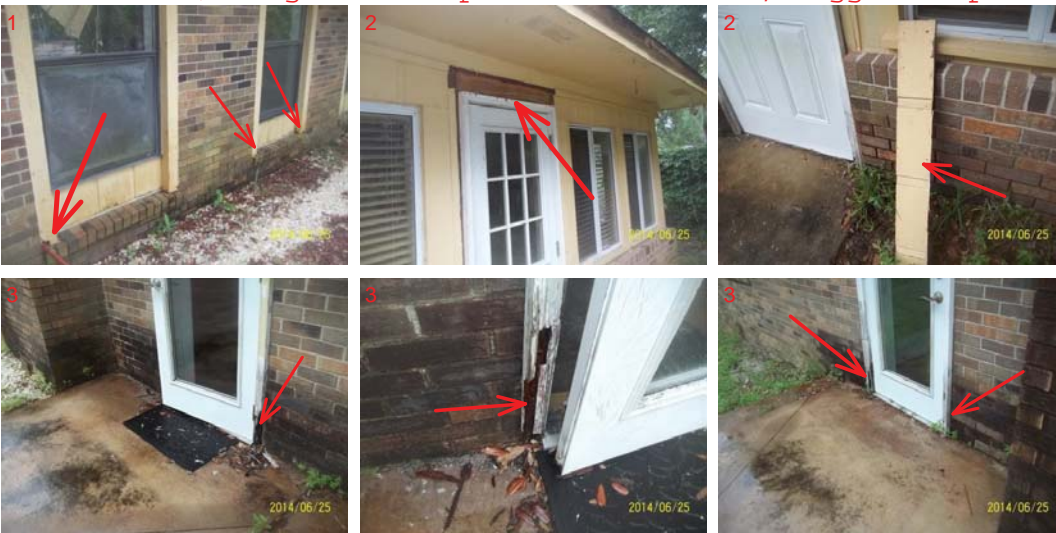
2. Trim: Wood 1. Wood rot in trim at front windows, suggest repair.
2. Trim removed at rear door frame, suggest replacement.
3. Wood rot/damage at all patio door frames, suggest repair.

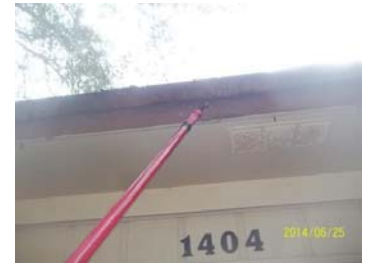
3. Fascia: Wood Wood rot in fascia at front of garage, suggest repair.

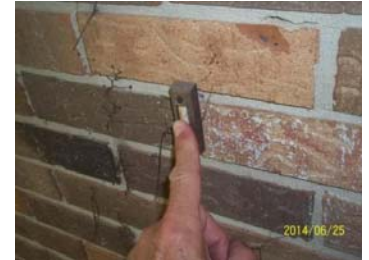
5. Door Bell: Hard wired Doorbell did not chime when activated, suggest repair/replacement.

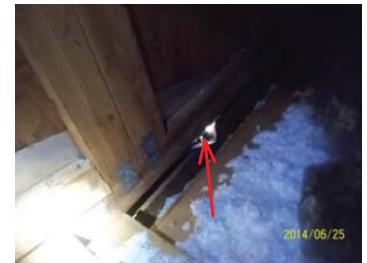
10. Flashing: Metal Flashing at right side front inadequate. Light can be seen from the attic at the kick-out flashing at the bottom of the right front rake. This indicates that water may enter the structure at this location, suggest further evaluation and repair by licensed roofing contractor.

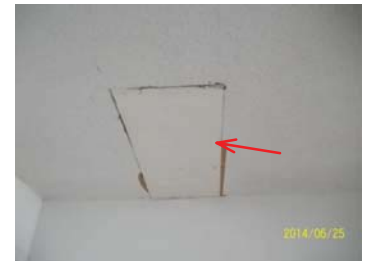
12. Front Left Garage Ceiling: Sheetrock-Paint **Incomplete patch at ceiling, suggest repair.**

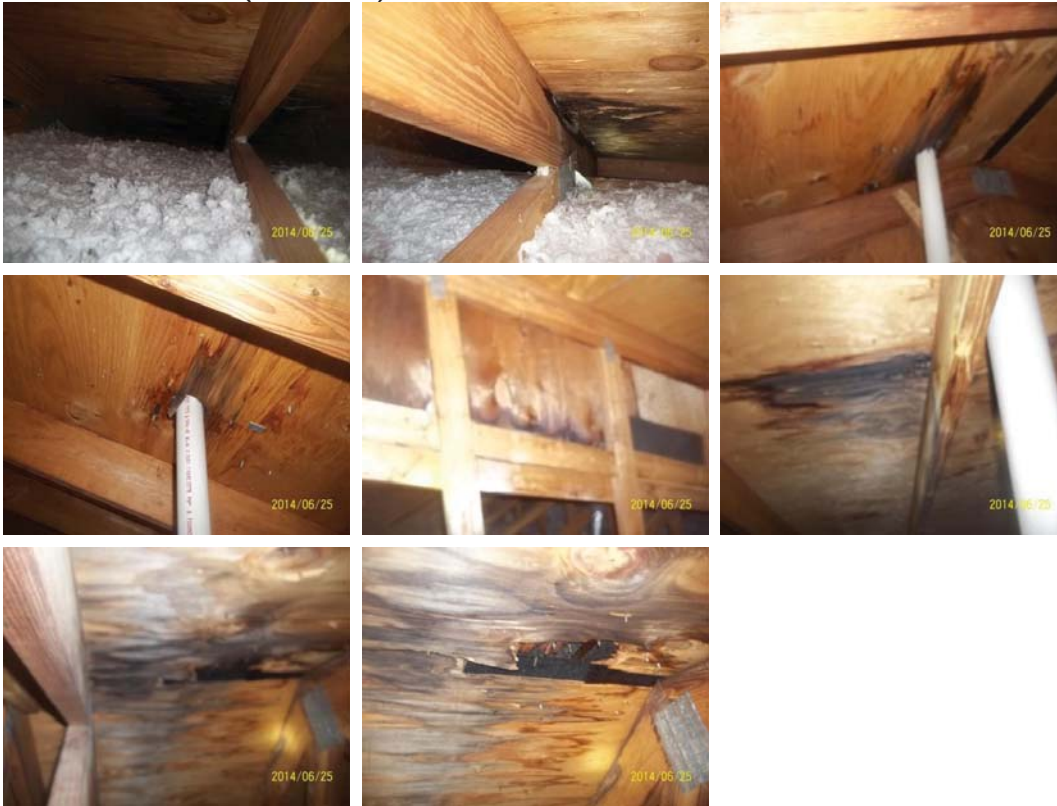
14. Main Attic Moisture Penetration: Ongoing water penetration noted **Water staining and penetration at all vent penetrations, suggest repair/replacement of vent boots. See remarks at Roof-Plumbing Vents.**
Water staining at front center above garage.
Water staining and sheathing damage at right side center (Near ridge), These areas should be evaluated by a Licensed roofing contractor to determine the integrity of the roofing system.

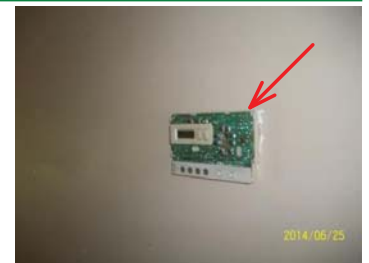
15. Thermostats: Individual Cover for thermostat not present, suggest replacement. Thermostat operated properly during inspection.

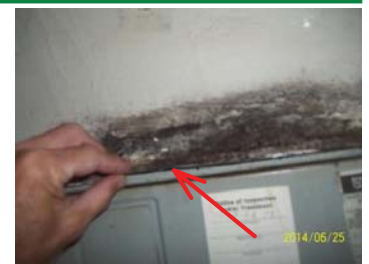
16. Utility Closet Heating System Distribution: Insulflex duct Loose connection at top of air handler, suggest sealing. Mildew growth at this location should be cleaned. Growth may be attributed to condensation caused by loose duct connection.

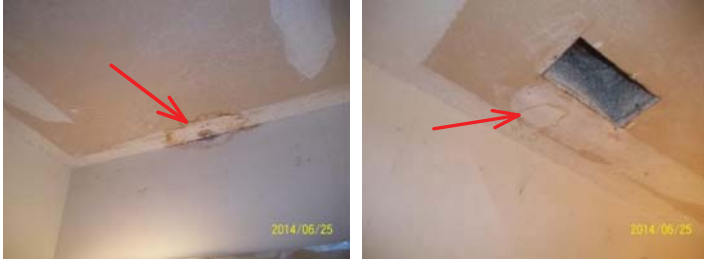
17. Master Bathroom Ceiling: Sheetrock-Paint Water staining at ceiling and incomplete finishing, suggest repair. See remarks at Roof-Plumbing Vents.

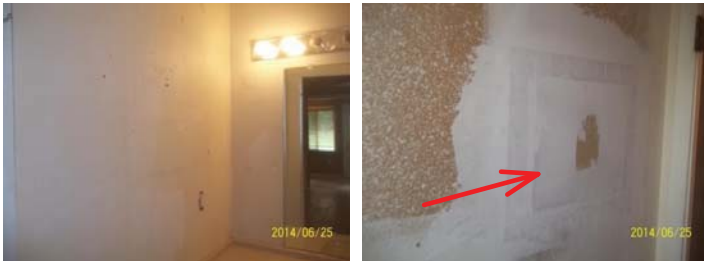
18. Master Bathroom Walls: Sheetrock-Paint Wallpaper removed from walls and incomplete patching, suggest repair.

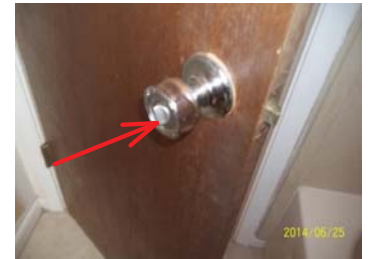
19. Master Bathroom Doors: Standard Door lock non-functional, suggest repair/replacement.

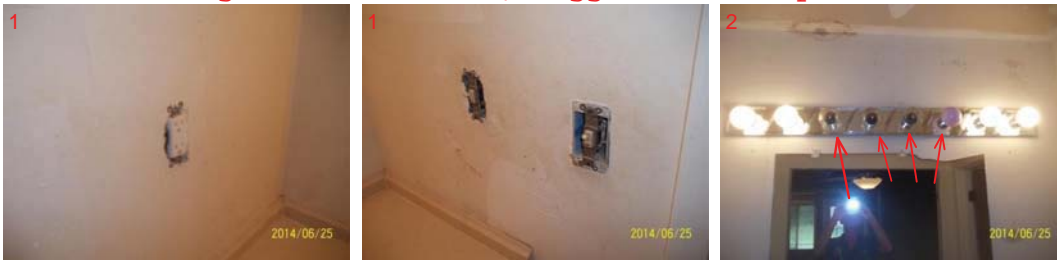
20. Master Bathroom Electrical: 110 VAC outlets and lighting circuits 1. Cover plates not installed at walls, suggest replacement.
2. Not all lights illuminated, suggest bulb replacement and re-test.

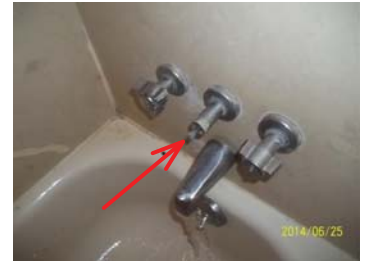
22. Master Bathroom Faucets/Traps: Metal/PVC Handle not present at shower diverter, suggest replacement.

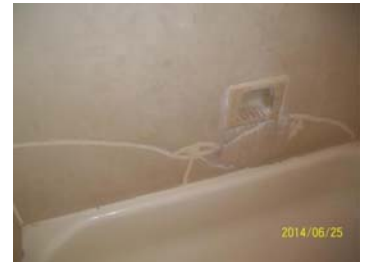
23. Master Bathroom Tub/Surround: Fiberglass tub and fiberglass surround Cracking in tub surround with caulking applied, suggest proper repair or replacement.

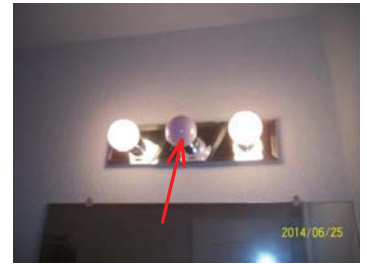
26. Right Hall Bathroom Electrical: 110 VAC outlets and lighting circuits
Not all lights illuminated, suggest bulb replacement and re-test.

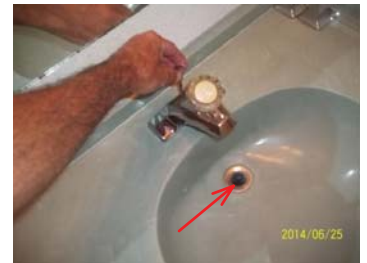
27. Right Hall Bathroom Sink/Basin: Molded single bowl Sink stopper damaged/not present at sink, suggest repair/replacement.

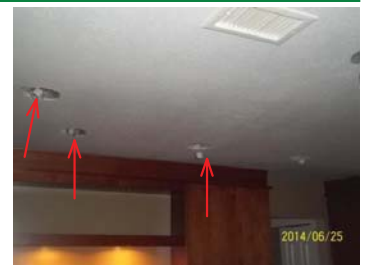
29. Main Kitchen Electrical: 110 VAC outlets and lighting circuits Light fixtures removed from ceiling, suggest replacement.

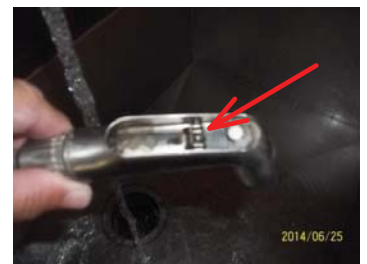
30. Main Kitchen Plumbing/Fixtures: Metal/PVC Spray handle damaged (operation handle not present), suggest repair/replacement.

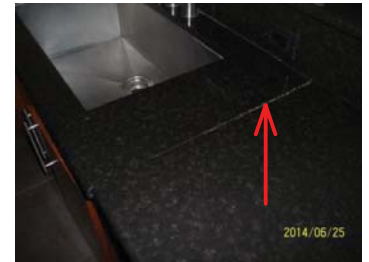
31. Main Kitchen Counter Tops: Stone Ill-fitting and uneven seams at counter-tops, suggest adjustment/repair.

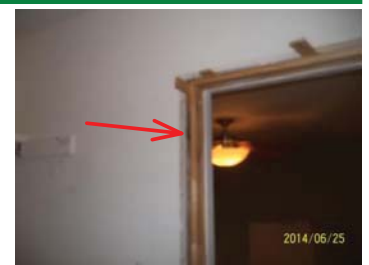
33. Master Bedroom Closet: Walk In Trim removed from interior frame of closet door, suggest replacement.

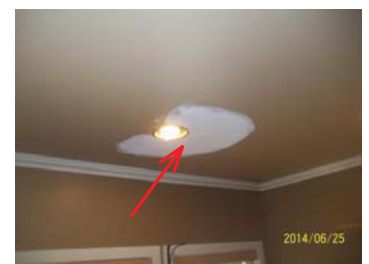
34. Master Bedroom Ceiling: Sheetrock-Paint Incomplete repair at ceiling of rear area of bedroom, suggest repair.

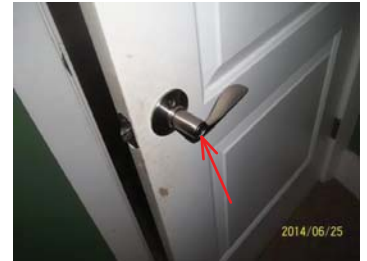
39. Right Rear Bedroom Doors: Standard Door lock non-functional, suggest repair/replacement.

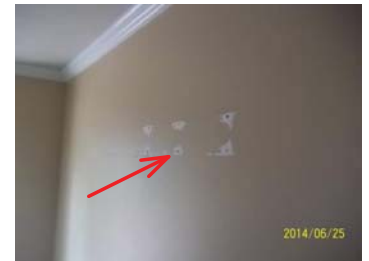
46. Dining Room Living Space Walls: Sheetrock-Paint Damage to right side wall, suggest repair.

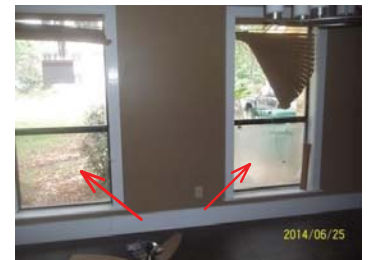
47. Dining Room Living Space Windows: Metal Single/Double hung Evidence of condensation between panes of glass indicate thermal seal is broken at both lower sashes, suggest repair/replacement.

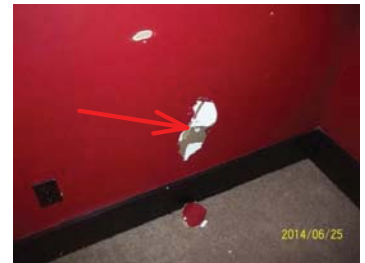
49. Office Area Living Space Walls: Sheetrock-Paint **Hole in rear wall, suggest repair.**

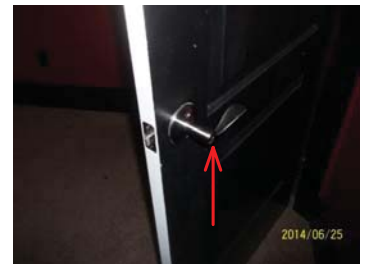
50. Office Area Living Space Doors: Standard **Door lock non-functional, suggest repair/replacement.**

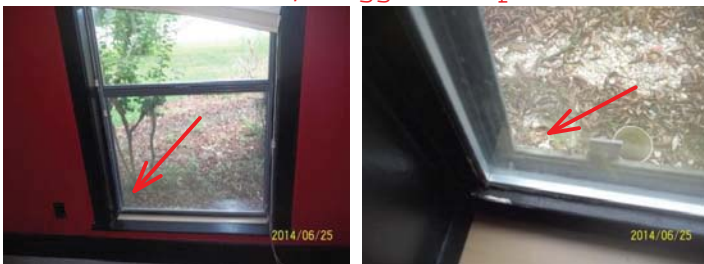
51. Office Area Living Space Windows: Metal Single/Double hung **Window screen damaged/not present at window, suggest replacement.**
