Stucco Moisture Inspection

**Address of Property
City, FL**

**STUCCO MOISTURE-SCAN INSPECTION
REPORT SUMMARY
Address of Inspection**

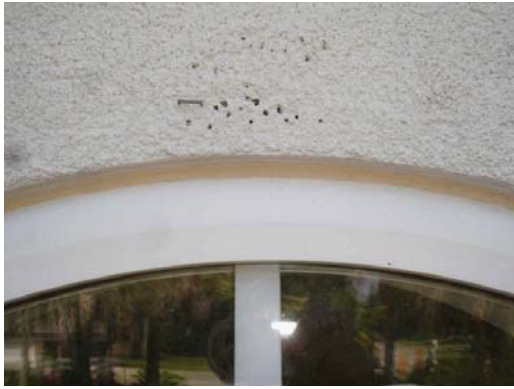
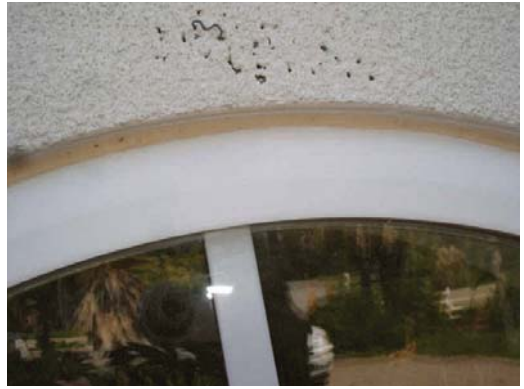
Item Description	Moisture Readings	Substrate Condition	Observations	Detail Photo #
E6	Windows	13	Firm	Acceptable Moisture	
E6	Windows	9	Firm	Acceptable Moisture	
F6	Windows	17	Firm	Acceptable Moisture	
G6	Wall	7	Firm	Acceptable Moisture	
A-J6-7	Wall			Vegetation impedes moisture evaporation, suggest vegetation be trimmed 18-24 inches from the wall	3
E4	Windows			Wall impact damage, suggest repair	1,2
E7	Wall			Previous repair noted	5

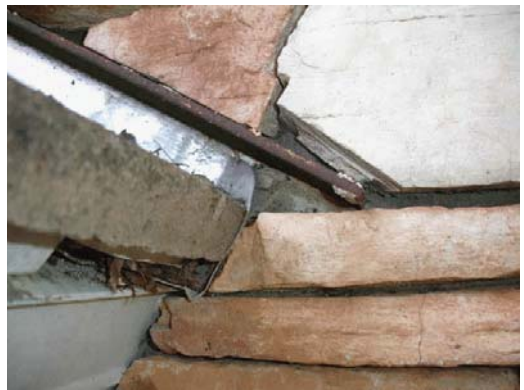
Item Description	Moisture Readings	Substrate Condition	Observations	Detail Photo #
B3	Kick-out	15	Firm	Acceptable Moisture	
E2	Windows	9	Firm	Acceptable Moisture	
F2	Windows	17	Firm	Acceptable Moisture	
F2	Windows	24	Firm	Elevated Moisture, suggest sealing	
G2	Windows	20	Firm	Acceptable Moisture	
B3	Kick-out			Kick-out flashing adequate	4
F2	Windows			Perimeter seal adequate	6
G2	Windows			Perimeter seal adequate	7

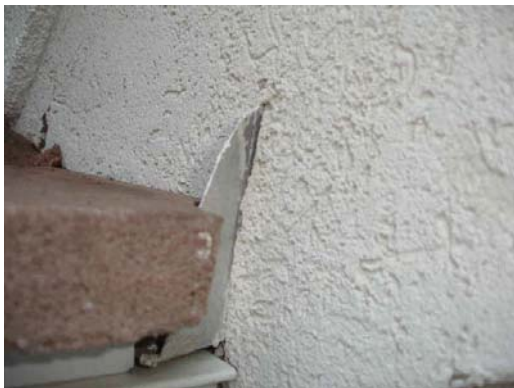
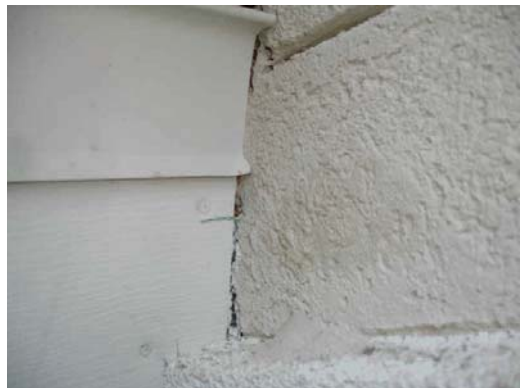
Item Description	Moisture Readings	Substrate Condition	Observations	Detail Photo #
F4	Kick-out	9	Firm	Acceptable Moisture	
G4	Kick-out	12	Firm	Acceptable Moisture	
F4	Kick-out			Kick-out flashing inadequate/improper, suggest repair	9,10
G4	Kick-out			Kick-out flashing inadequate/improper, suggest repair	11
H4	Soffit			Pest activity, suggest pest control technician to evaluate	12
XX	Wall			Vegetation impedes moisture evaporation, suggest vegetation be trimmed 18-24 inches from the wall

OBSERVATION #6: Roof edge kick-out (diverter) flashing was observed to be missing or inadequate at required locations. Missing or inadequate kickout (diverter) flashing roof termination locations in the wall surface can allow water entry into the substrate system and interior wall locations.

SUGGESTION: All in wall roof terminations should have missing or inadequate kickout flashing should be repaired or reinstalled in a proper manner to prevent water entry into the substrate area.

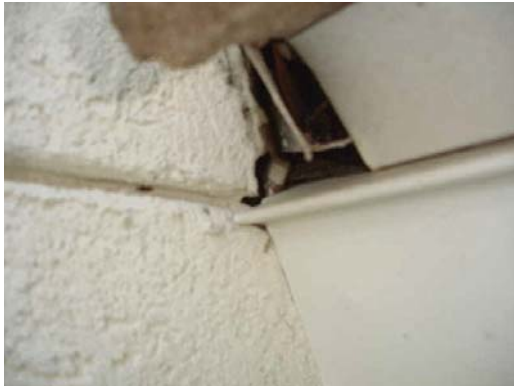
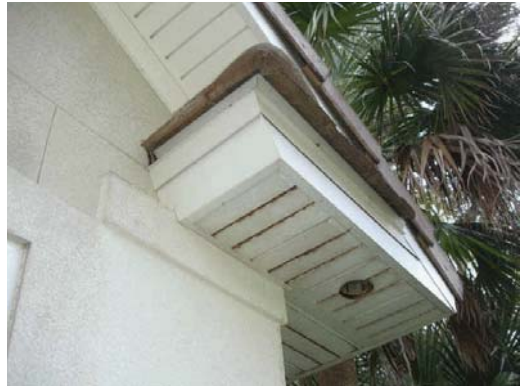
Item Description	Moisture Readings	Substrate Condition	Observations	Detail Photo #
C5	Utility			Wall penetration seal missing/inadequate, suggest sealing	13
F6	Utility			Wall penetration seal missing/inadequate, suggest sealing	14
F4	Windows			Perimeter seal inadequate, suggest sealing	15

OBSERVATION #5: Unsealed wall penetrations (breaches) were observed at random places around the building. These penetrations include; plumbing pipes; HVAC lines; drainpipes; electrical lines; sub-system attaching screws, etc. These penetrations provide avenues for water to penetrate the surface and enter the substrate. The presence of elevated/high moisture in the wood substrate, if allowed to remain, will cause the molecules of the wood to react and wood rot to occur.

SUGGESTION: All wall penetrations should be sealed/resealed as necessary to prevent water penetration below the wall surface. The sealant process, including type of sealant, should be as recommended by the stucco manufacturer.

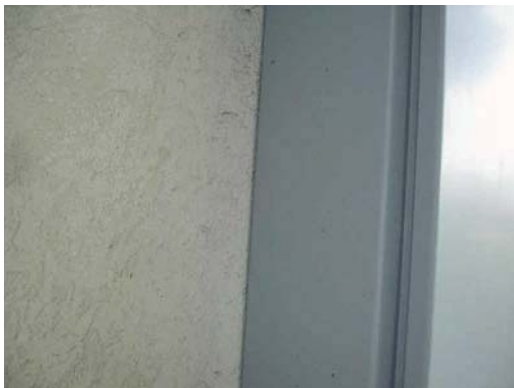
15

OBSERVATION #3: Adhesive and/or cohesive failure of sealant was observed at some places around window and door frames. The failure of the sealant creates small gaps in the exterior water barrier system of the building. These gaps provide an avenue for water to penetrate the exterior stucco barrier and potentially enter the substrate behind the stucco.

SUGGESTION: All window and door frames should be resealed as necessary to prevent water from penetrating to the substrate. The sealant process should be as specified by the stucco manufacturer or as a minimum in accord with industry standards.

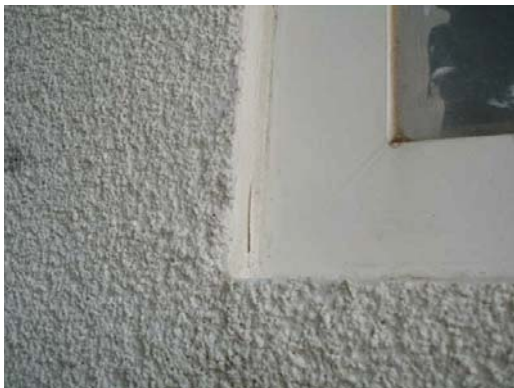
Item Description	Moisture Readings	Substrate Condition	Observations	Detail Photo #
F7	Windows	9	Firm	Acceptable Moisture	
G7	Windows	8	Firm	Acceptable Moisture	
C5	Screen			Wall penetration seal missing/inadequate, suggest sealing	17
C-D7	Wall			Missing and loose stone, suggest repair	18
F6	Windows			Wall impact damage, suggest repair	19

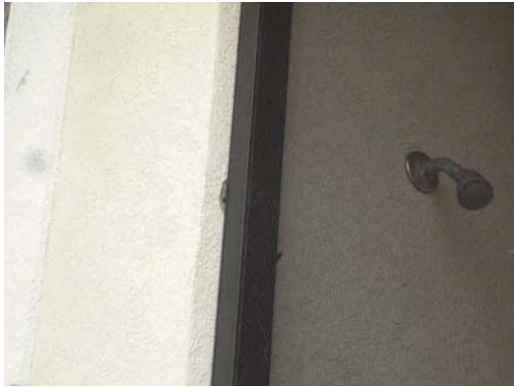
19

OBSERVATION #8: Stucco surface damage was observed at one or more locations on the wall. The impact breaks in the surface can allow water to penetrate below the surface and into the substrate. (See **Sec. 3.6**)

SUGGESTION: All impact damage should be repaired and resealed in accordance with manufacturer recommendation to prevent water penetration behind the surface.

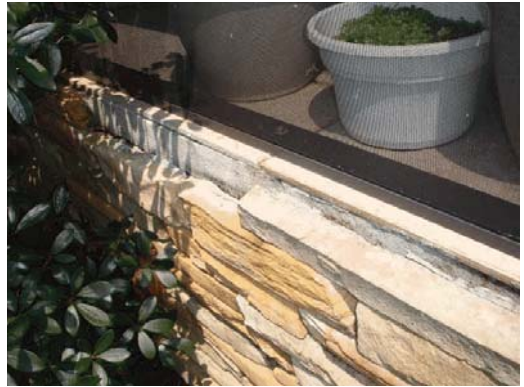
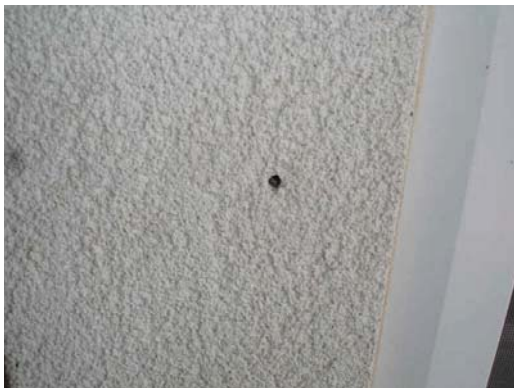
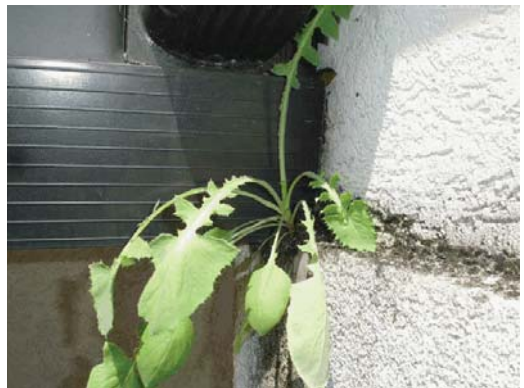
Item Description	Moisture Readings	Substrate Condition	Observations	Detail Photo #
I2	Column			Vegetation growing on the column, suggest removal	20
I3	Column			Mildew/mold growth on wall, suggest cleaning	21
I7	Column			Mildew/mold growth on wall, suggest cleaing	22

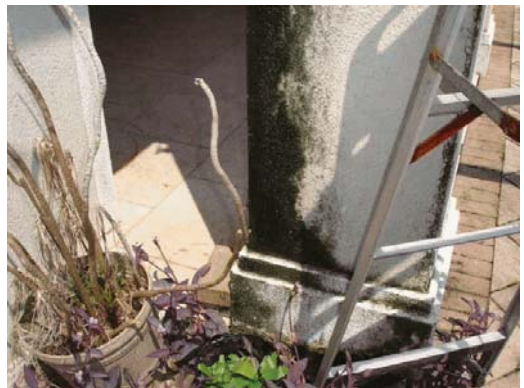
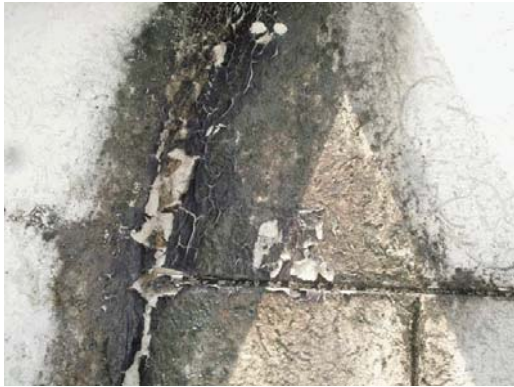
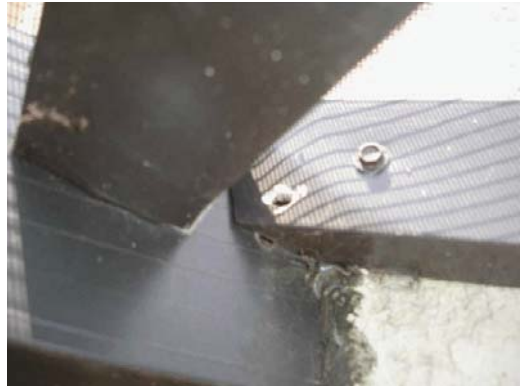
Item Description	Moisture Readings	Substrate Condition	Observations	Detail Photo #
E2	End Dam	40	Soft	HIGH MOISTURE, suggest intrusive exam and repair	
E6	Windows	XX	Soft	Too soft to determine moisture suggest intrusive exam and repair	
F6	Windows	XX	Soft	Too soft to determine moisture suggest intrusive exam and repair	
F6	Windows	XX	Soft	Too soft to determine moisture suggest intrusive exam and repair	
D2	Wall			Mildew/mold growth on wall, suggest cleaning	23
E1	Screen			Hole in frame, suggest sealing	24
D6	Wall			Mildew/mold growth on wall, suggest cleaning	25
G2	Wall			Wall impact damage, sugges repair	26

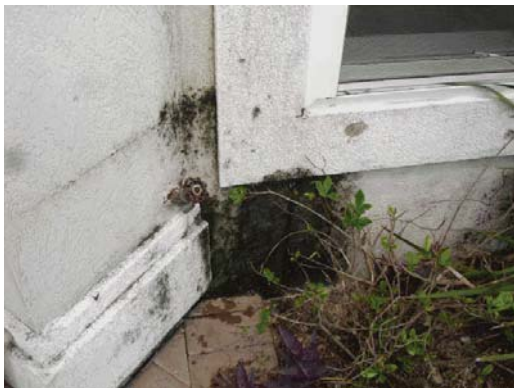
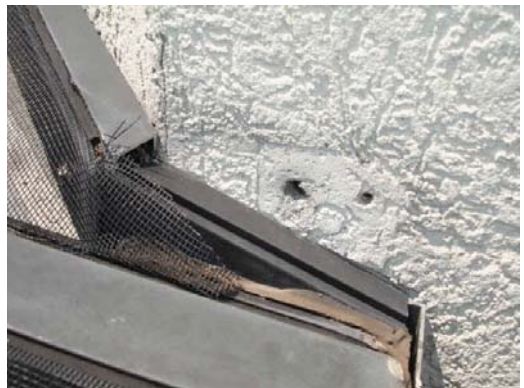
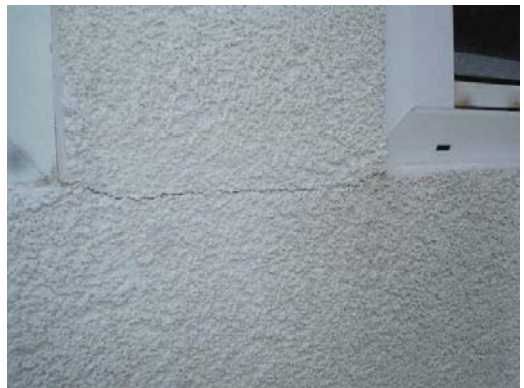
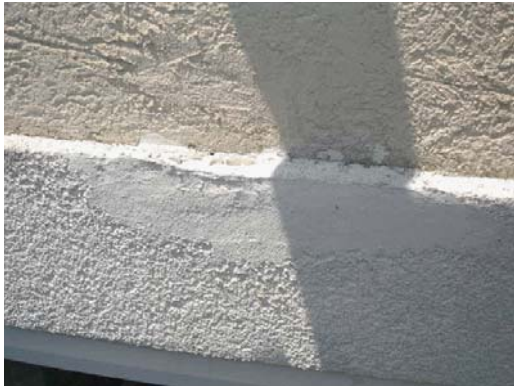
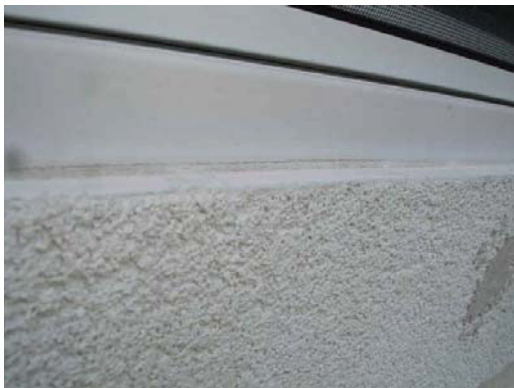
Item Description	Moisture Readings	Substrate Condition	Observations	Detail Photo #
C6	Windows			Perimeter seal inadequate, suggest sealing	27
E6	Windows			Stucco surface crack, suggest sealing	28
F6	Windows			Perimeter seal inadequate, suggest sealing	30
G6	Windows			Perimeter seal inadequate, suggest sealing	31
H6	Windows			Perimeter seal inadequate, suggest sealing	33

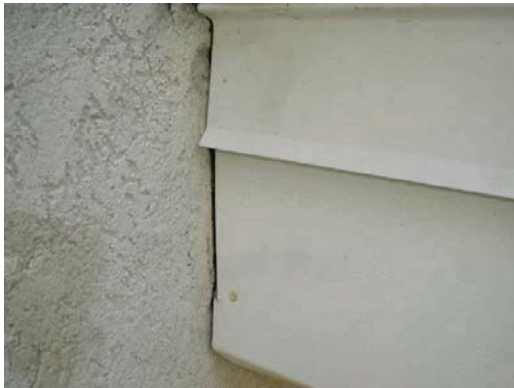
Item Description	Moisture Readings	Substrate Condition	Observations	Detail Photo #
D7	Windows	13	Firm	Acceptable Moisture	
D7	Windows	11	Firm	Acceptable Moisture	
E7	Windows	23	Firm	Acceptable Moisture	
E7	Windows	17	Firm	Acceptable Moisture	
E6	Windows			Perimeter seal inadequate, suggest sealing	39
XX	Wall			Vegetation impedes moisture evaporation, suggest vegetation be trimmed 18-24 inches from the wall
