Stucco Moisture Inspection

**Address of Property
City, FL**

**STUCCO MOISTURE-SCAN INSPECTION
REPORT SUMMARY
Address of Inspection**

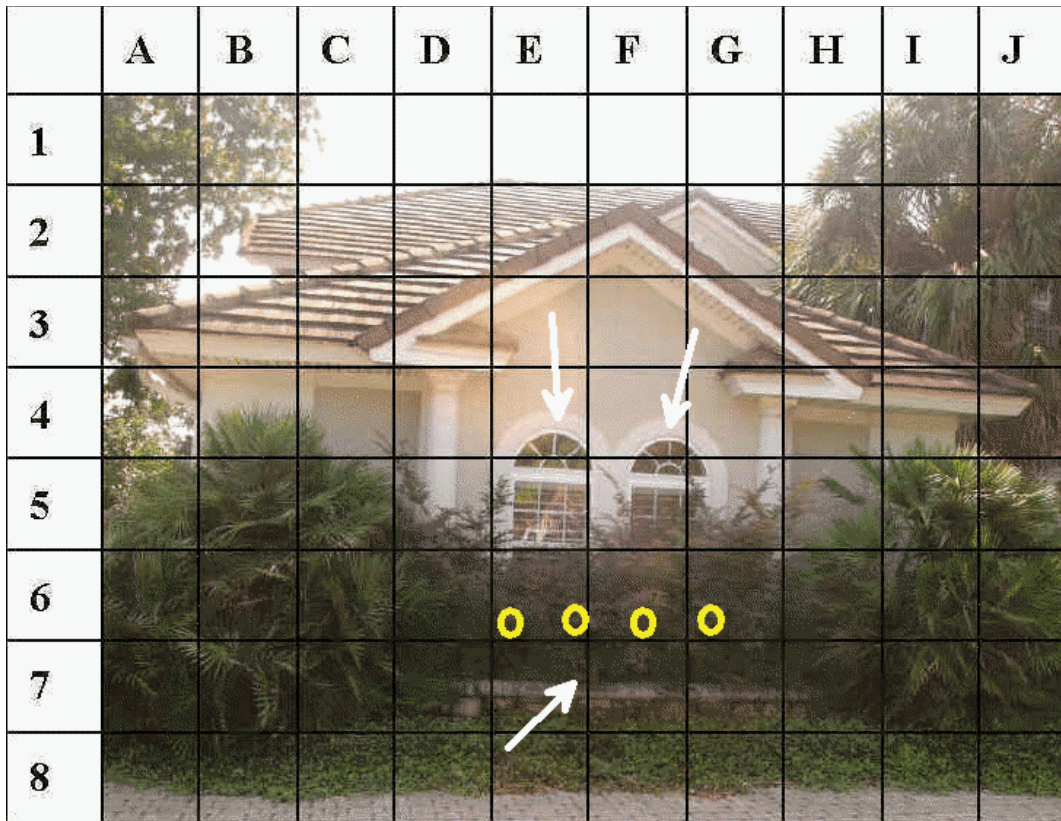
Elevation Page #1

Item Description	Moisture Readings	Substrate Condition	Observations	Detail Photo #
E6	Windows	13	Firm	Acceptable Moisture	
E6	Windows	9	Firm	Acceptable Moisture	
F6	Windows	17	Firm	Acceptable Moisture	
G6	Wall	7	Firm	Acceptable Moisture	
A-J6-7	Wall			Vegetation impedes moisture evaporation, suggest vegetation be trimmed 18-24 inches from the wall	3
E4	Windows			Wall impact damage, suggest repair	1,2
E7	Wall			Previous repair noted	5

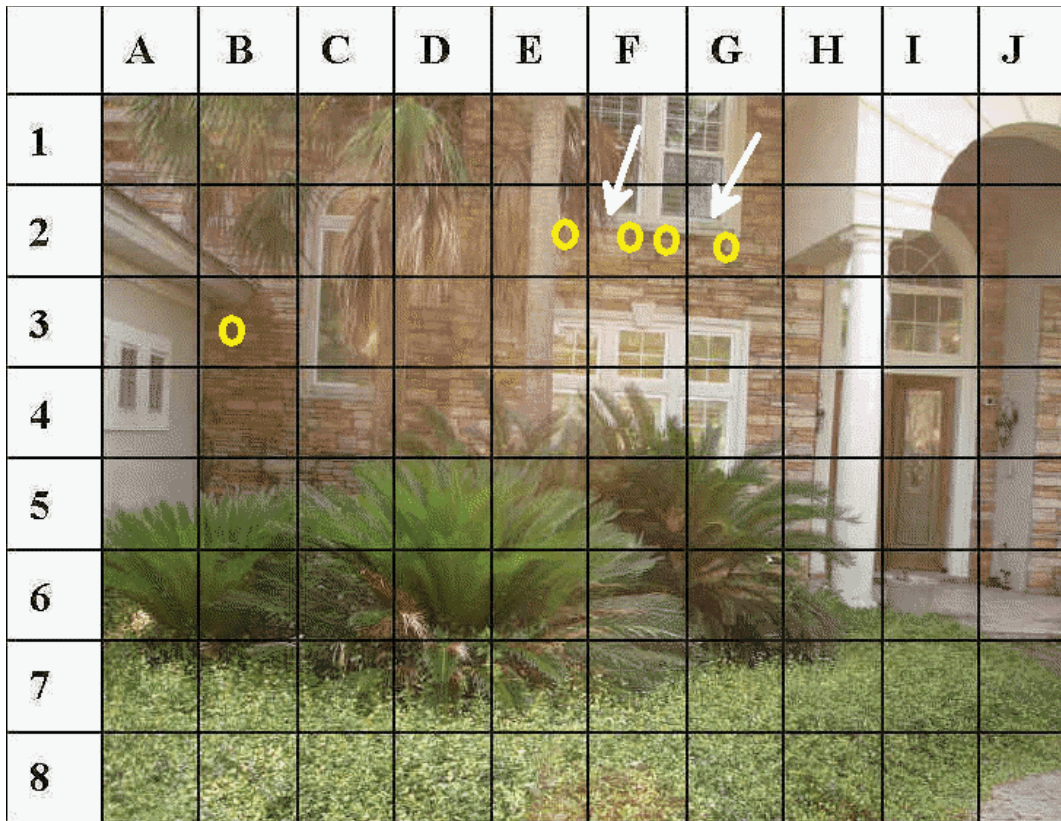
Elevation Page #2

Item Description	Moisture Readings	Substrate Condition	Observations	Detail Photo #
B3	Kick-out	15	Firm	Acceptable Moisture	
E2	Windows	9	Firm	Acceptable Moisture	
F2	Windows	17	Firm	Acceptable Moisture	
F2	Windows	24	Firm	Elevated Moisture, suggest sealing	
G2	Windows	20	Firm	Acceptable Moisture	
B3	Kick-out			Kick-out flashing adequate	4
F2	Windows			Perimeter seal adequate	6
G2	Windows			Perimeter seal adequate	7

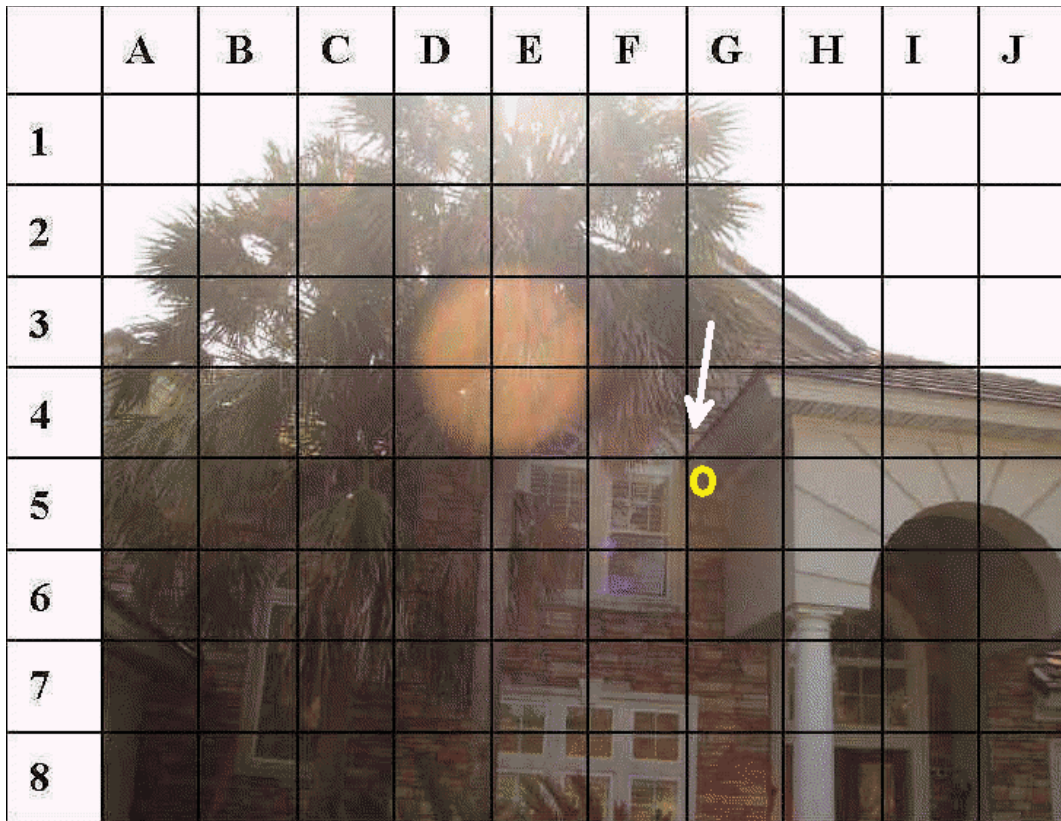
Elevation Page #3

Item Description	Moisture Readings	Substrate Condition	Observations	Detail Photo #
G5	Kick-out	9	Firm	Acceptable Moisture	
G4	Kick-out			Kick-out flashing adequate

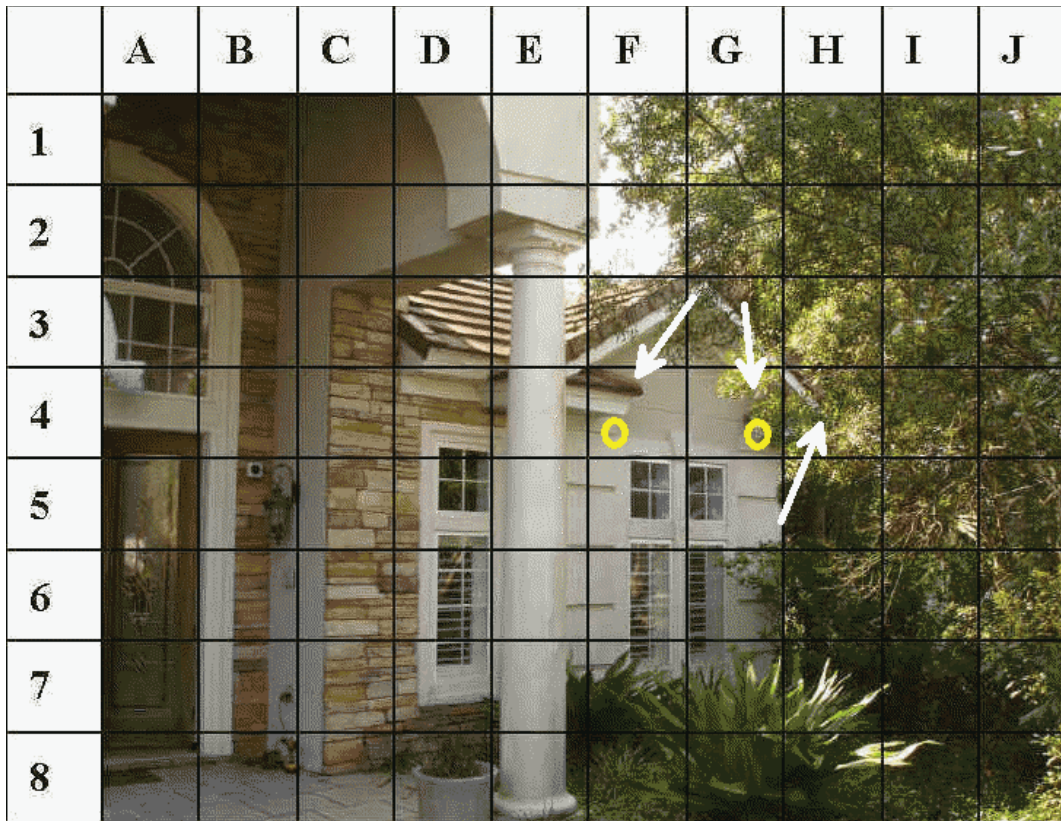
Elevation Page #4

Item Description	Moisture Readings	Substrate Condition	Observations	Detail Photo #
F4	Kick-out	9	Firm	Acceptable Moisture	
G4	Kick-out	12	Firm	Acceptable Moisture	
F4	Kick-out			Kick-out flashing inadequate/improper, suggest repair	9,10
G4	Kick-out			Kick-out flashing inadequate/improper, suggest repair	11
H4	Soffit			Pest activity, suggest pest control technician to evaluate	12
XX	Wall			Vegetation impedes moisture evaporation, suggest vegetation be trimmed 18-24 inches from the wall

SUGGESTION: All in wall roof terminations should have missing or inadequate kickout flashing should be repaired or reinstalled in a proper manner to prevent water entry into the substrate area.

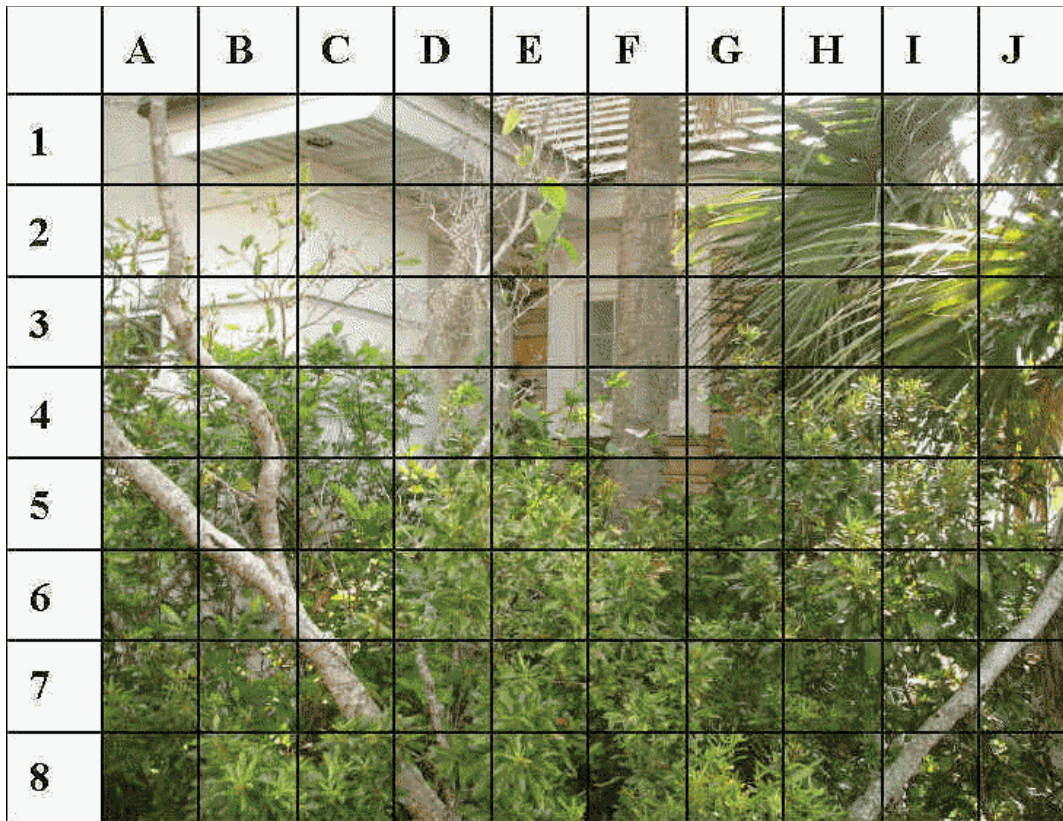
Elevation Page #5

Item Description	Moisture Readings	Substrate Condition	Observations	Detail Photo #
XX	Wall			Vegetation impedes moisture evaporation, suggest vegetation be trimmed 18-24 inches from the wall

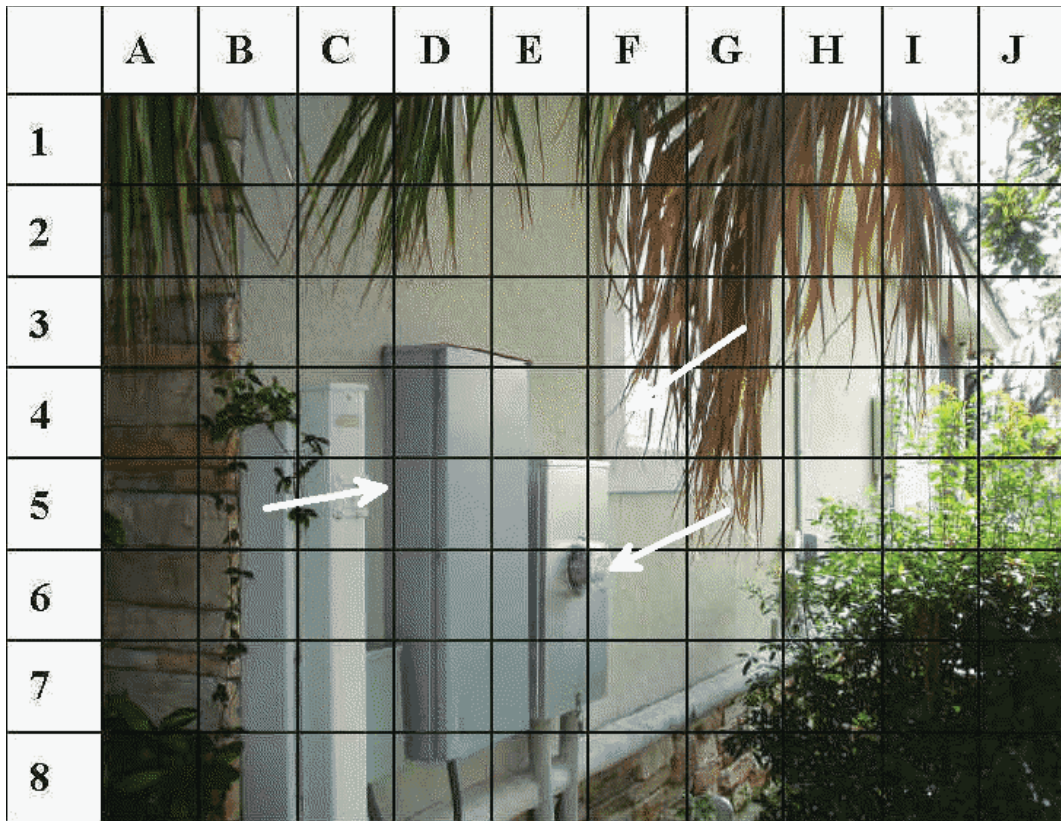
Elevation Page #6

Item Description	Moisture Readings	Substrate Condition	Observations	Detail Photo #
C5	Utility			Wall penetration seal missing/inadequate, suggest sealing	13
F6	Utility			Wall penetration seal missing/inadequate, suggest sealing	14
F4	Windows			Perimeter seal inadequate, suggest sealing	15

SUGGESTION: All wall penetrations should be sealed/resealed as necessary to prevent water penetration below the wall surface. The sealant process, including type of sealant, should be as recommended by the stucco manufacturer.

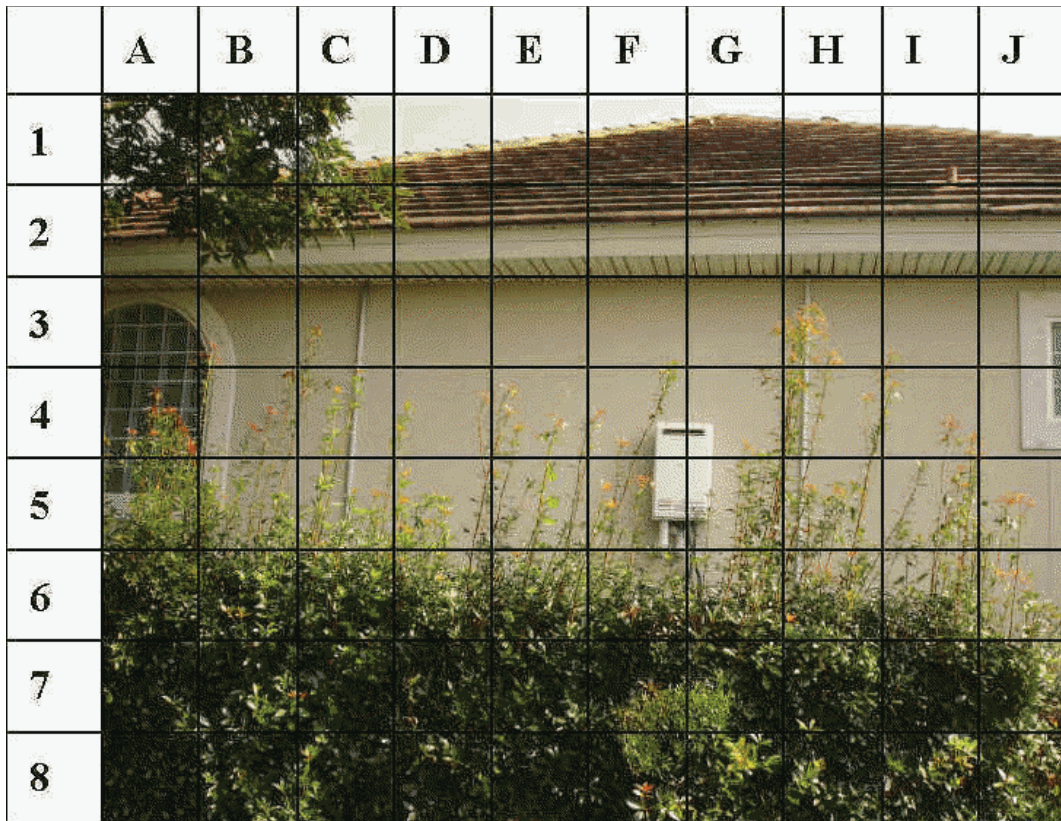
Elevation Page #7

Item Description	Moisture Readings	Substrate Condition	Observations	Detail Photo #
A-J6-7	Wall			Vegetation impedes moisture evaporation, suggest vegetation be trimmed 18-24 inches from the wall	16

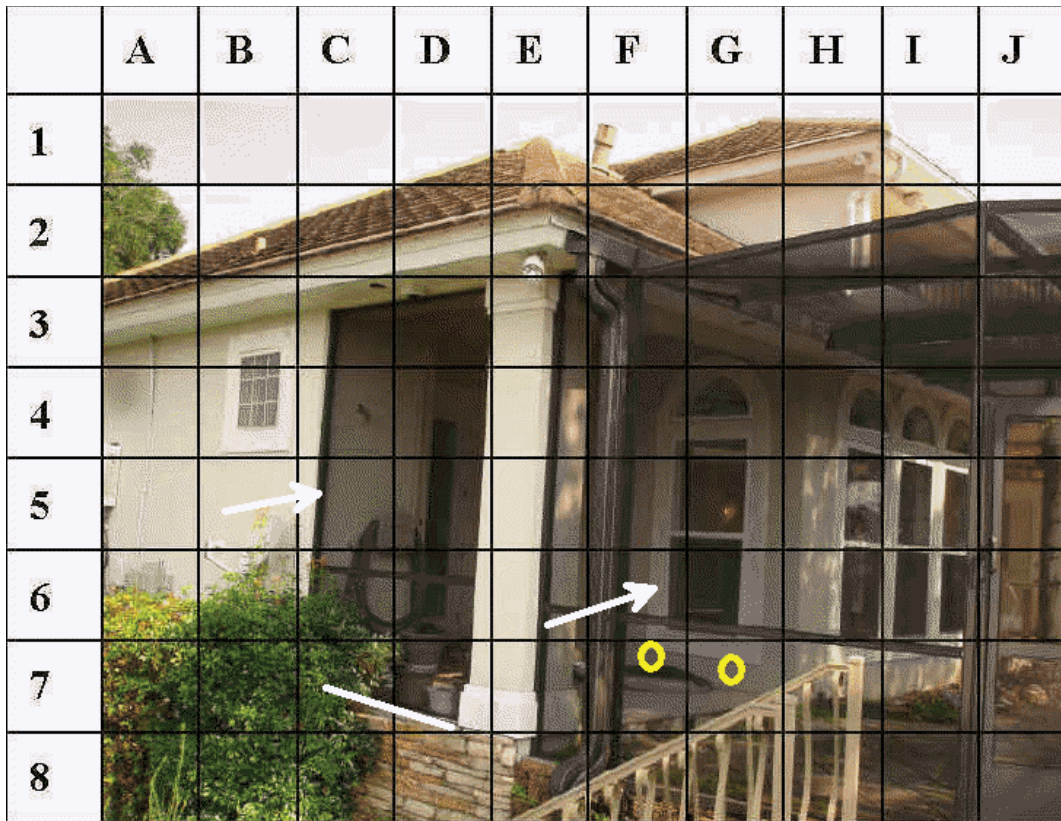
Elevation Page #8

Item Description	Moisture Readings	Substrate Condition	Observations	Detail Photo #
F7	Windows	9	Firm	Acceptable Moisture	
G7	Windows	8	Firm	Acceptable Moisture	
C5	Screen			Wall penetration seal missing/inadequate, suggest sealing	17
C-D7	Wall			Missing and loose stone, suggest repair	18
F6	Windows			Wall impact damage, suggest repair	19

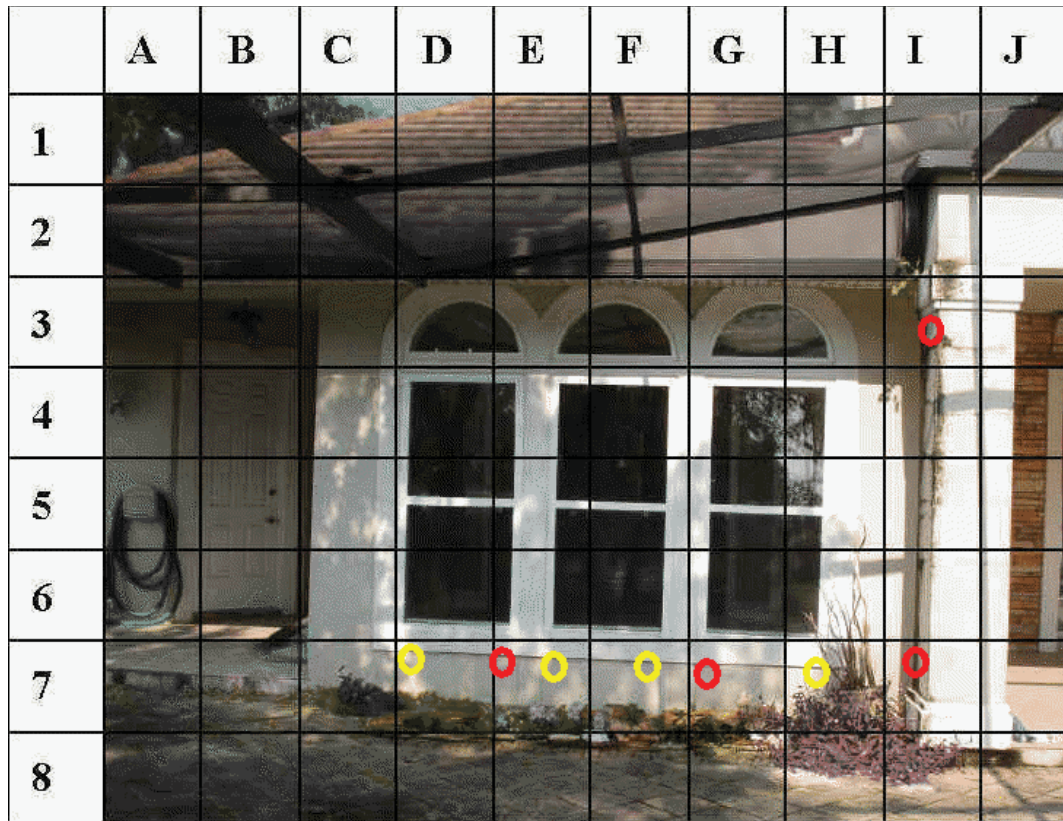
Elevation Page #9

Item Description	Moisture Readings	Substrate Condition	Observations	Detail Photo #
D7	Windows	11	Firm	Acceptable Moisture	
E7	Windows	19	Soft	Acceptable Moisture, suggest intrusive exam and repair	
E7	Windows	9	Firm	Acceptable Moisture	
F7	Windows	10	Firm	Acceptable Moisture	
G7	Windows	40	Soft	HIGH MOISTURE, suggest intrusive exam and repair	
H7	Windows	23	Firm	Elevated Moisture, suggest sealing	
I3	Column	40	Soft	HIGH MOISTURE, suggest intrusive exam and repair	
I7	Column	40	QuasiSoft	HIGH MOISTURE, suggest intrusive exam and repair

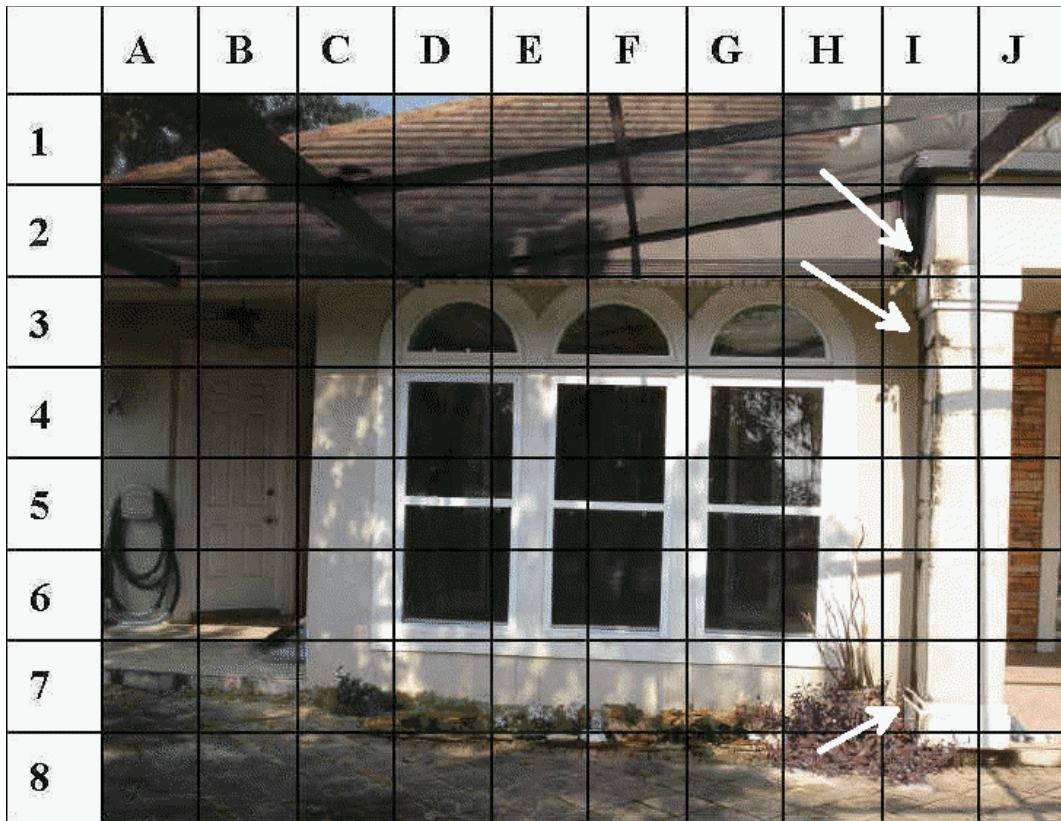
Elevation Page #9a

Item Description	Moisture Readings	Substrate Condition	Observations	Detail Photo #
I2	Column			Vegetation growing on the column, suggest removal	20
I3	Column			Mildew/mold growth on wall, suggest cleaning	21
I7	Column			Mildew/mold growth on wall, suggest cleaing	22

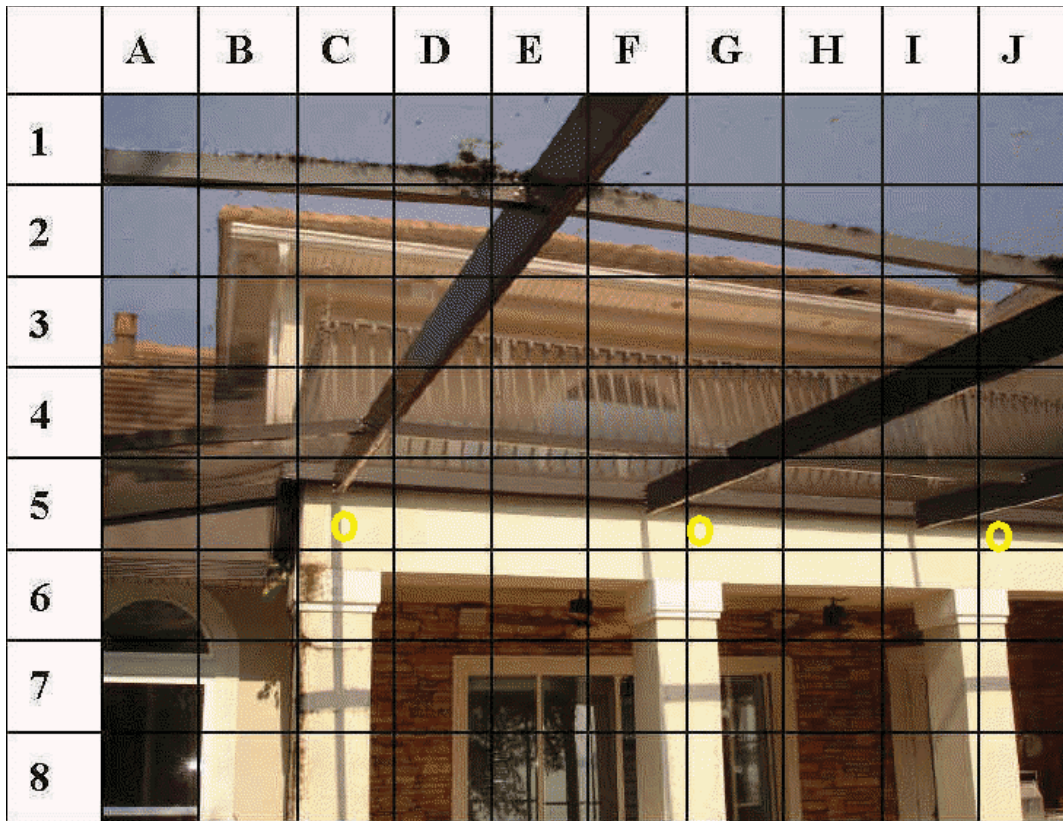
Elevation Page #11

Item Description	Moisture Readings	Substrate Condition	Observations	Detail Photo #
C5	Balcony	14	Firm	Acceptable Moisture	
G5	Balcony	7	Firm	Acceptable Moisture	
J5	Balcony	7	Firm	Acceptable Moisture

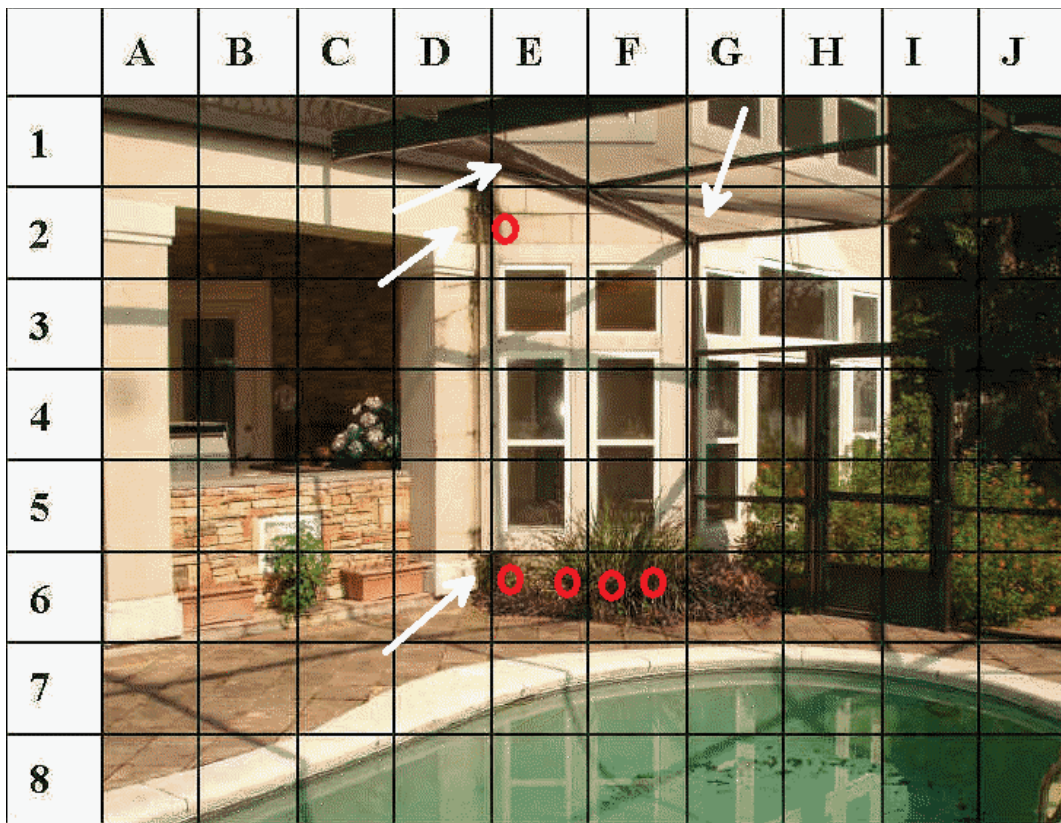
Elevation Page #13

Item Description	Moisture Readings	Substrate Condition	Observations	Detail Photo #
E2	End Dam	40	Soft	HIGH MOISTURE, suggest intrusive exam and repair	
E6	Windows	XX	Soft	Too soft to determine moisture suggest intrusive exam and repair	
F6	Windows	XX	Soft	Too soft to determine moisture suggest intrusive exam and repair	
F6	Windows	XX	Soft	Too soft to determine moisture suggest intrusive exam and repair	
D2	Wall			Mildew/mold growth on wall, suggest cleaning	23
E1	Screen			Hole in frame, suggest sealing	24
D6	Wall			Mildew/mold growth on wall, suggest cleaning	25
G2	Wall			Wall impact damage, sugges repair	26

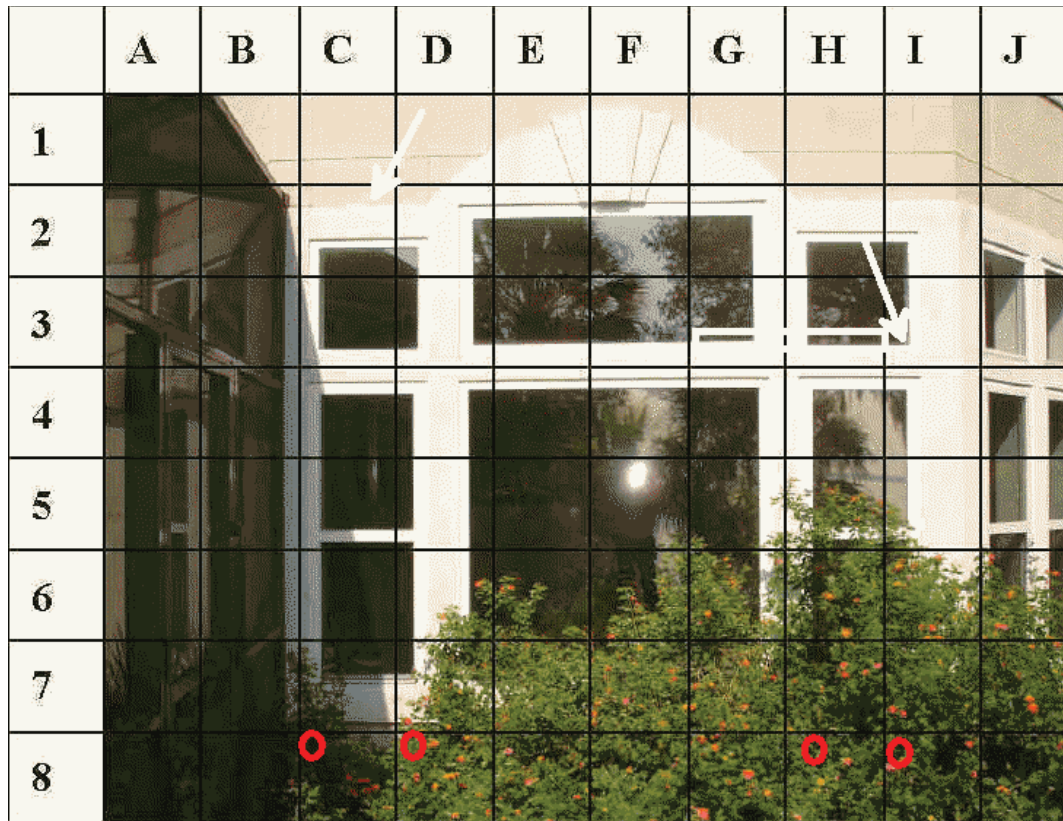
Elevation Page #14

Item Description	Moisture Readings	Substrate Condition	Observations	Detail Photo #
C8	Windows	XX	Soft	Too soft to determine moisture suggest intrusive exam and repair	
D8	Windows	XX	Soft	Too soft to determine moisture suggest intrusive exam and repair	
H8	Windows	XX	Soft	Too soft to determine moisture suggest intrusive exam and repair	
I8	Windows	XX	Soft	Too soft to determine moisture suggest intrusive exam and repair	
C2	Windows			Previous repair	29
I3	Windows			Wall impact damage, suggest repair	32
G-H3	Windows			Inside windows have excessive silicone sealant	34,35
XX	Wall			Vegetation impedes moisture evaporation, suggest vegetation be trimmed 18-24 inches from the wall

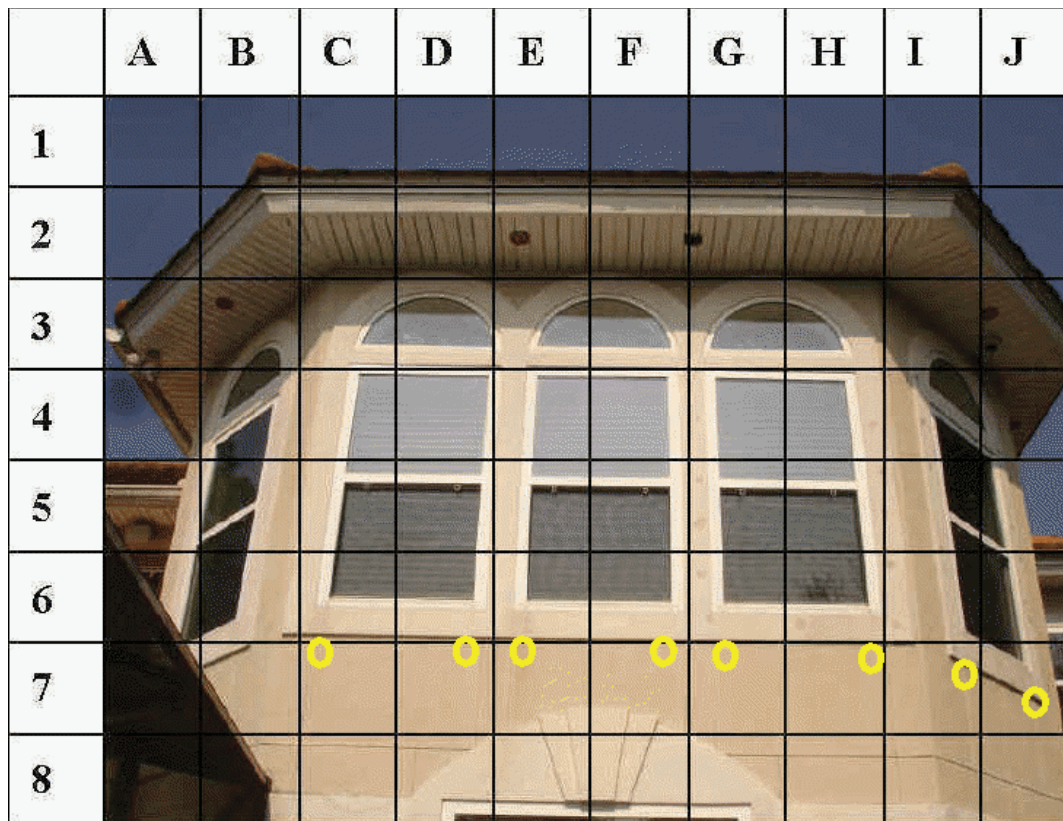
Elevation Page #15

Item Description	Moisture Readings	Substrate Condition	Observations	Detail Photo #
C7	Windows	20	Firm	Acceptable Moisture	
D7	Windows	16	Firm	Acceptable Moisture	
E7	Windows	14	Firm	Acceptable Moisture	
F7	Windows	8	Firm	Acceptable Moisture	
G7	Windows	18	Firm	Acceptable Moisture	
H7	Windows	25	Firm	HIGH MOISTURE, suggest further exam and sealing as needed	
I7	Windows	11	Firm	Acceptable Moisture	
J7	Windows	8	Firm	Acceptable Moisture

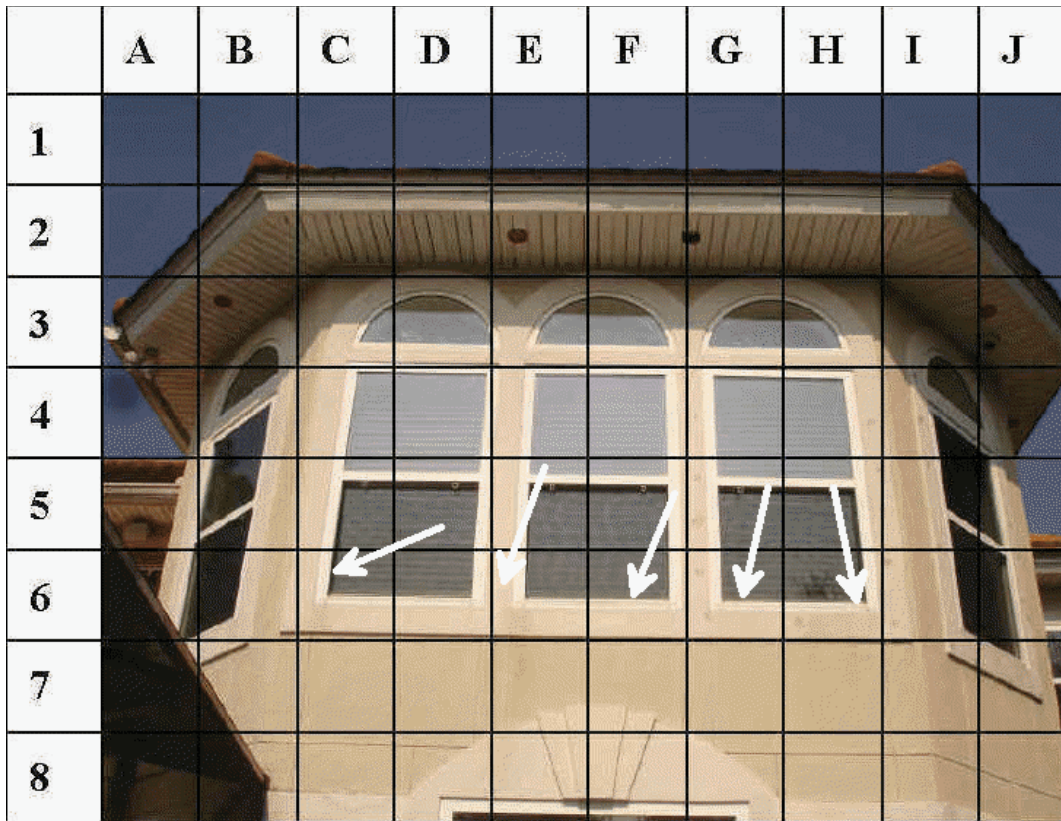
Elevation Page #15a

Item Description	Moisture Readings	Substrate Condition	Observations	Detail Photo #
C6	Windows			Perimeter seal inadequate, suggest sealing	27
E6	Windows			Stucco surface crack, suggest sealing	28
F6	Windows			Perimeter seal inadequate, suggest sealing	30
G6	Windows			Perimeter seal inadequate, suggest sealing	31
H6	Windows			Perimeter seal inadequate, suggest sealing	33

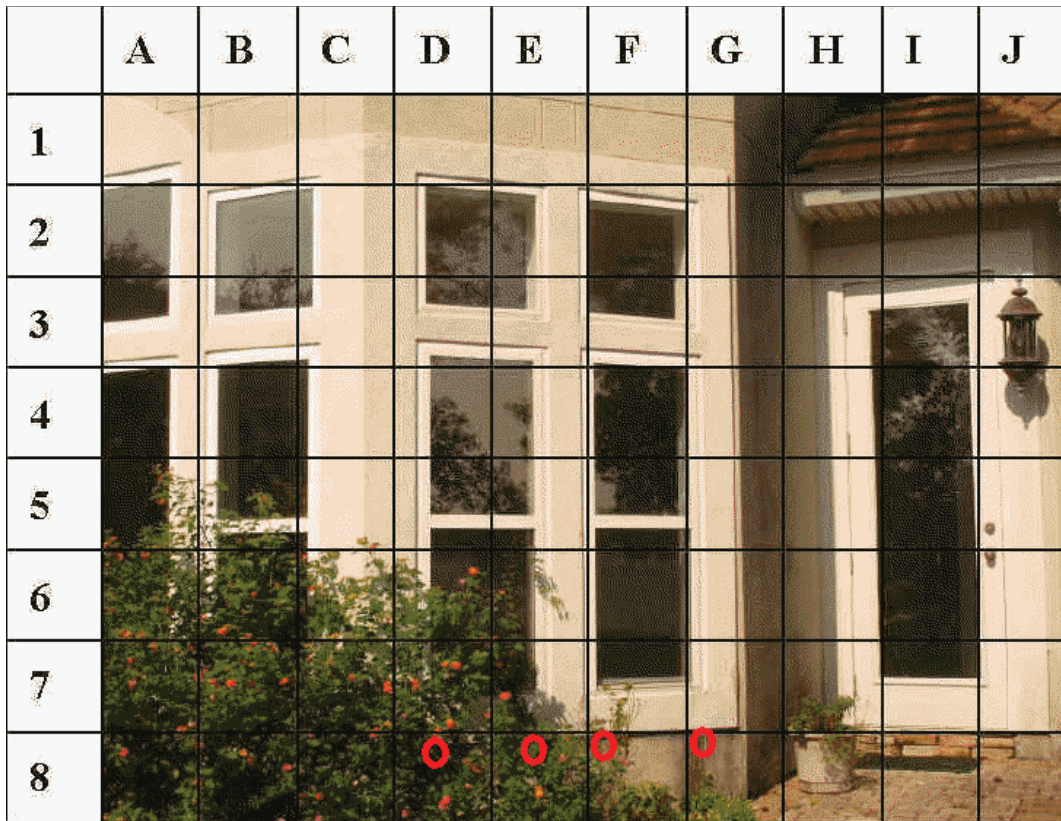
Elevation Page #16

Item Description	Moisture Readings	Substrate Condition	Observations	Detail Photo #
D8	Windows	XX	Soft	Too soft to determine moisture suggest intrusive exam and repair	
E8	Windows	XX	Soft	Too soft to determine moisture suggest intrusive exam and repair	
F8	Windows	40	QuasiSoft	HIGH MOISTURE, suggest intrusive exam and repair	
G8	Windows	XX	Soft	Too soft to determine moisture suggest intrusive exam and repair

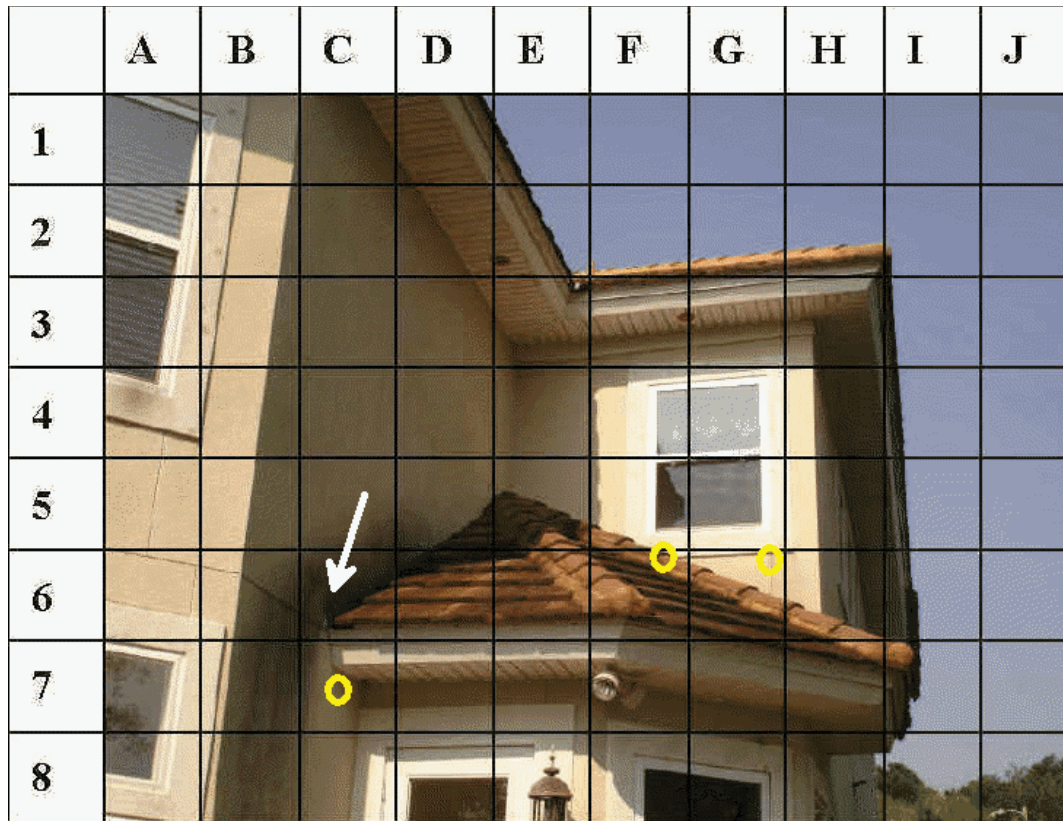
Elevation Page #17

Item Description	Moisture Readings	Substrate Condition	Observations	Detail Photo #
C7	Kick-out	22	Firm	Acceptable Moisture	
F6	Windows	20	Firm	Acceptable Moisture	
G6	Windows	9	Firm	Acceptable Moisture	
C6	Kick-out			Kick-out flashing inadequate/improper, suggest repair	36,37

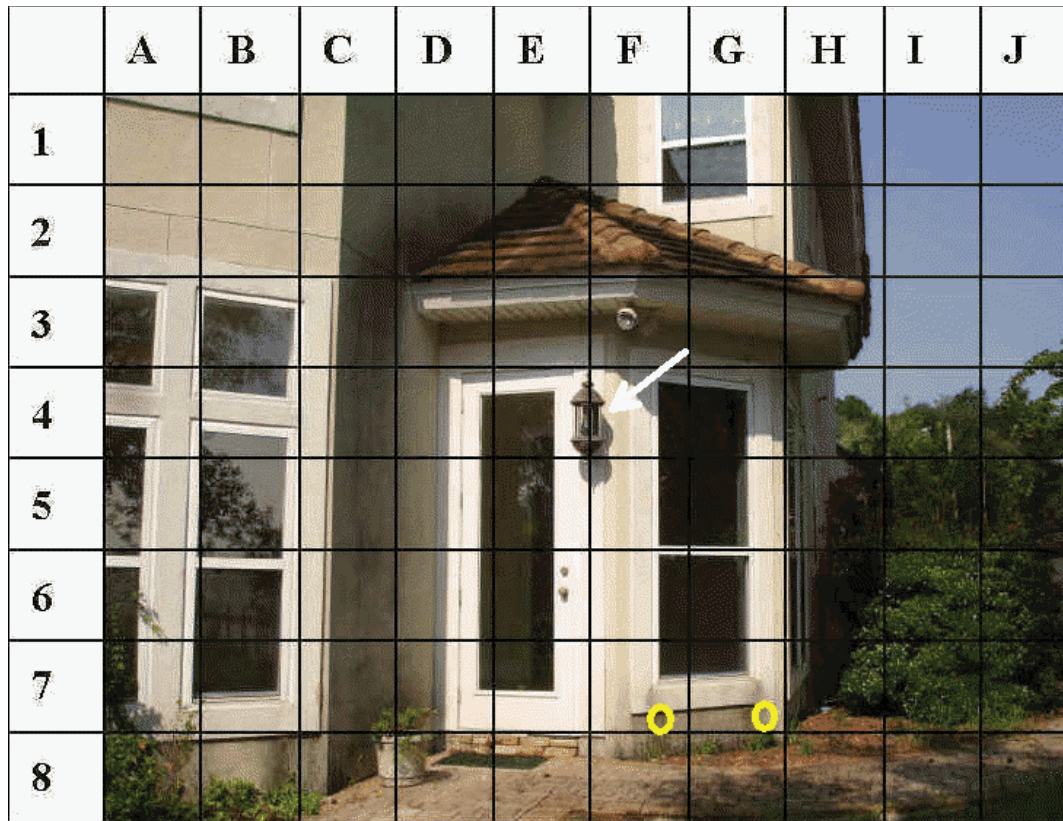
Elevation Page #18

Item Description	Moisture Readings	Substrate Condition	Observations	Detail Photo #
F7	Windows	29	Firm	HIGH MOISTURE, suggest further exam and sealing as needed	
G7	Windows	20	Firm	Acceptable Moisture	
F4	Light			Wall penetration seal missing/inadequate, suggest sealing	38
XX				Vegetation impedes moisture evaporation, suggest vegetation be trimmed 18-24 inches from the wall

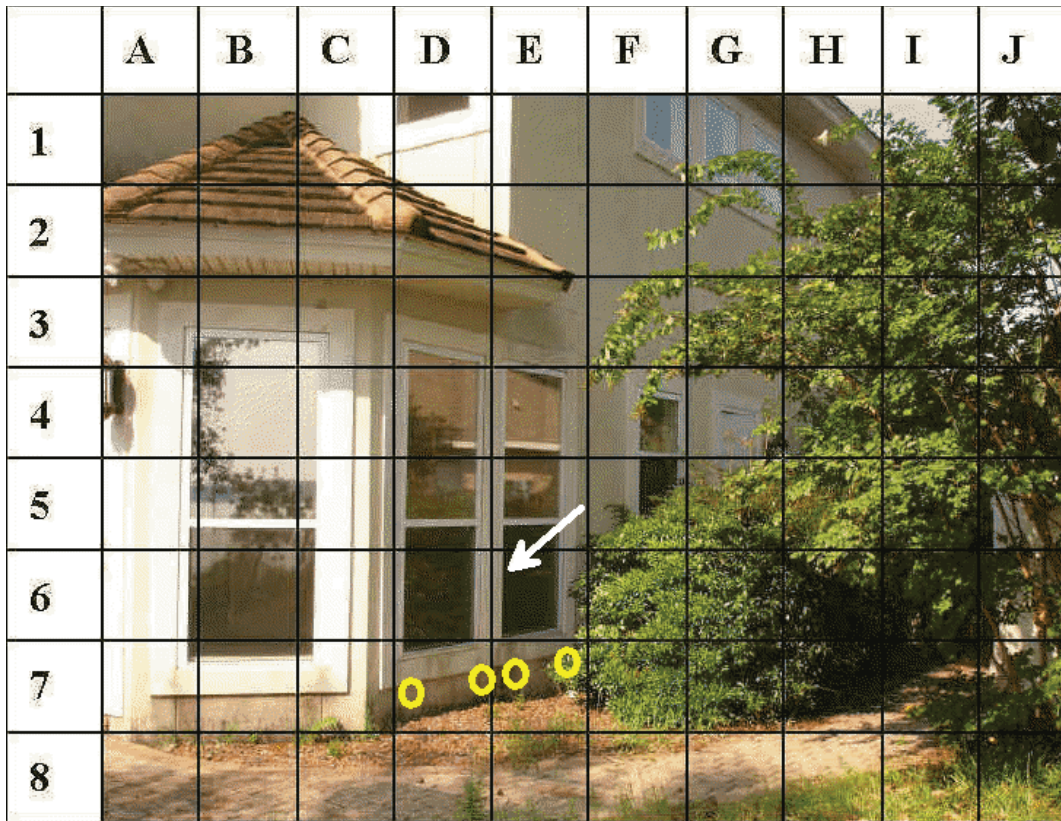
Elevation Page #19

Item Description	Moisture Readings	Substrate Condition	Observations	Detail Photo #
D7	Windows	13	Firm	Acceptable Moisture	
D7	Windows	11	Firm	Acceptable Moisture	
E7	Windows	23	Firm	Acceptable Moisture	
E7	Windows	17	Firm	Acceptable Moisture	
E6	Windows			Perimeter seal inadequate, suggest sealing	39
XX	Wall			Vegetation impedes moisture evaporation, suggest vegetation be trimmed 18-24 inches from the wall

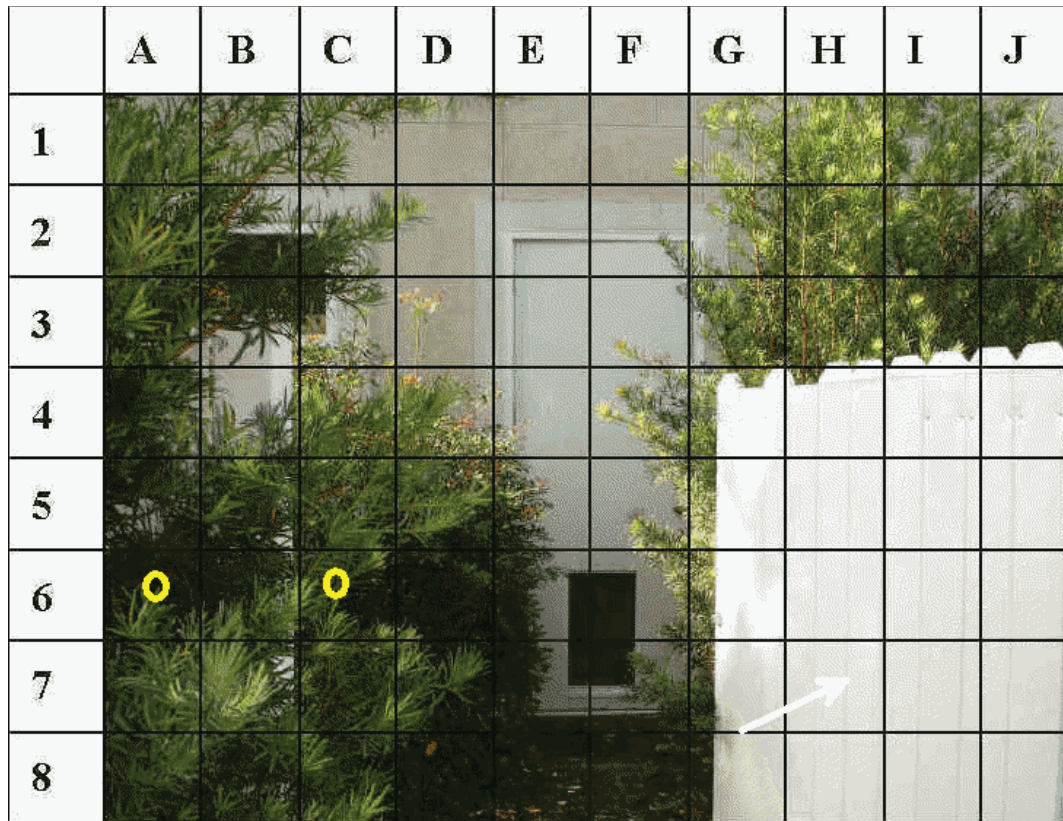
Elevation Page #21

Item Description	Moisture Readings	Substrate Condition	Observations	Detail Photo #
A6	Windows	13	Firm	Acceptable Moisture	
C6	Windows	9	Firm	Acceptable Moisture	
H7	Utility			Wall penetration seal missing/inadequate, suggest sealing	40
XX	Wall			Vegetation impedes moisture evaporation, suggest vegetation be trimmed 18-24 inches from the wall

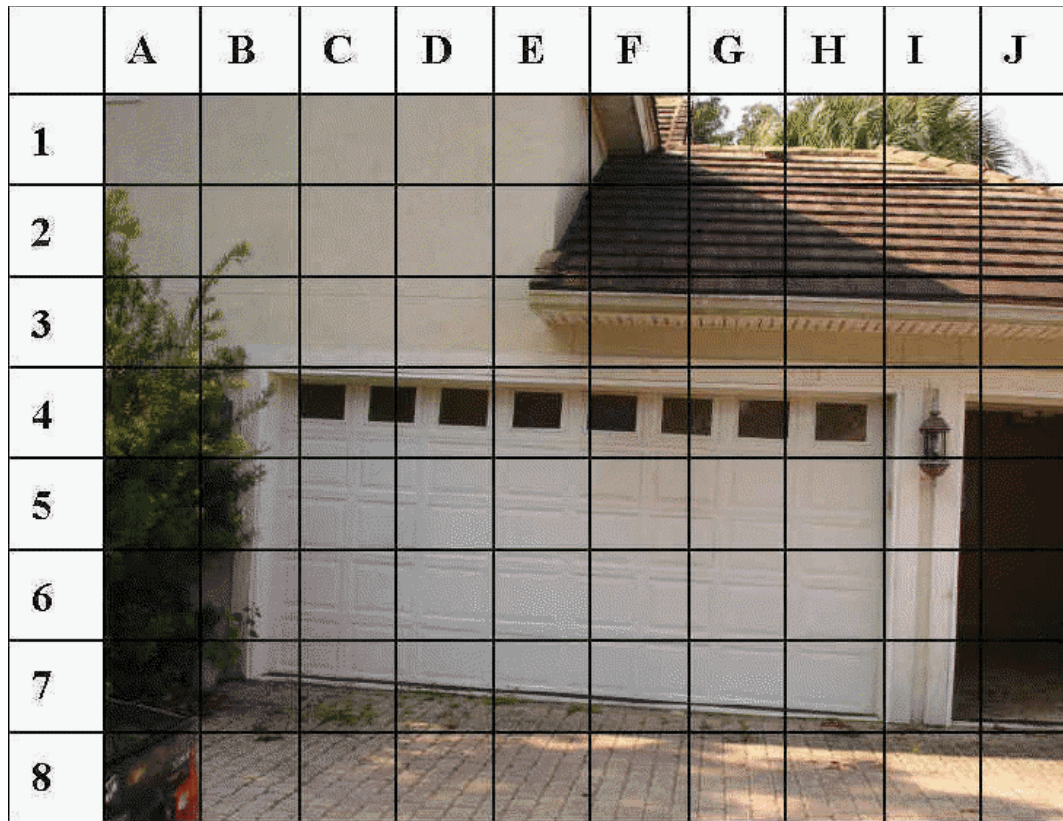
Elevation Page #22

Item Description	Moisture Readings	Substrate Condition	Observations	Detail Photo #
XX	Wall			Vegetation impedes moisture evaporation, suggest vegetation be trimmed 18-24 inches from the wall

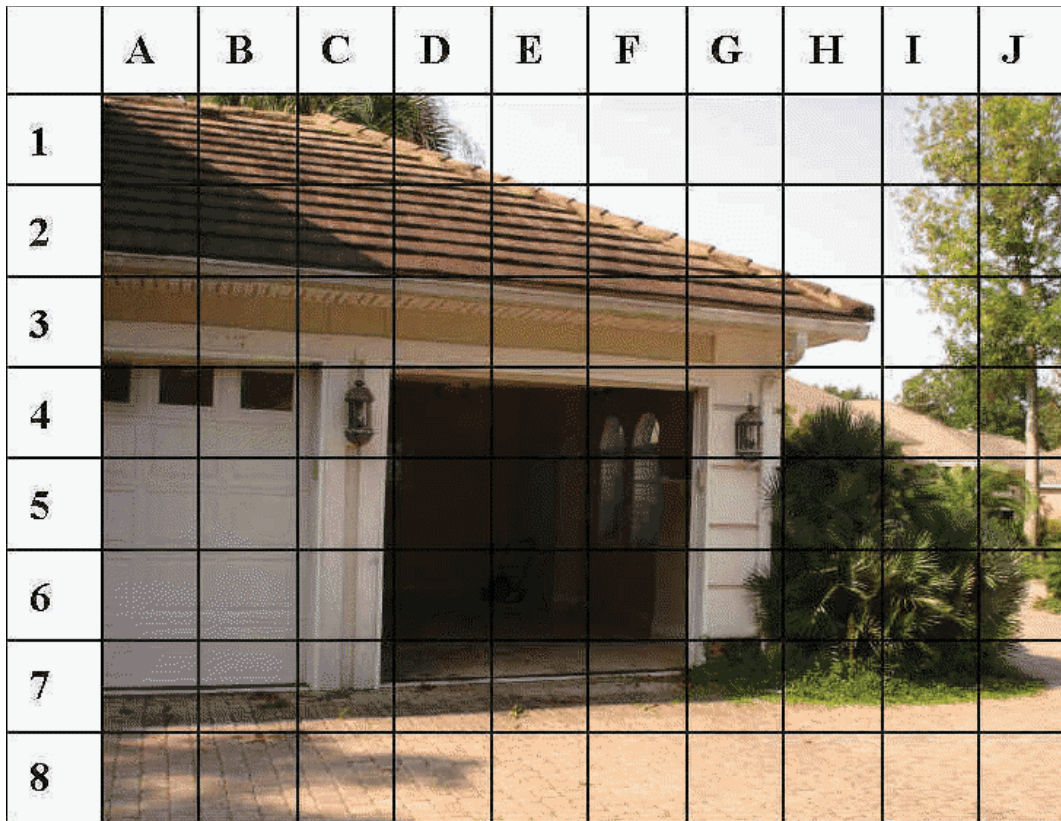
Elevation Page #23

Item Description	Moisture Readings	Substrate Condition	Observations	Detail Photo #
XX	Wall			Vegetation impedes moisture evaporation, suggest vegetation be trimmed 18-24 inches from the wall
