American Property Inspectors

Home Inspection

1111 Old School House Rd
Somewhere, FL

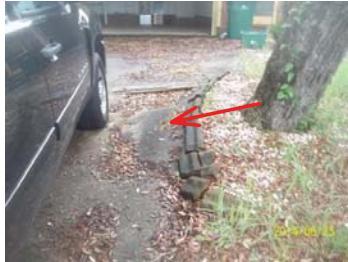
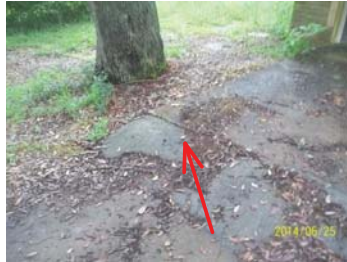
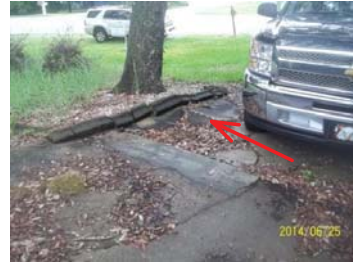
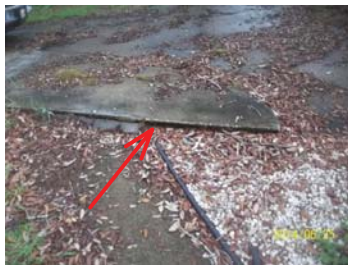
1. Driveway: Concrete Heaving and displacement noted at driveway. This is possibly caused by root growth of nearby trees, suggest further evaluation by qualified technician to determine the appropriate remedy. There is a trip hazard present at time of inspection.

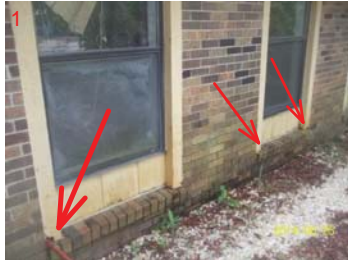
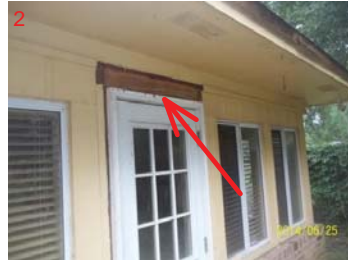
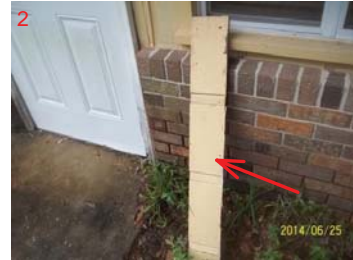
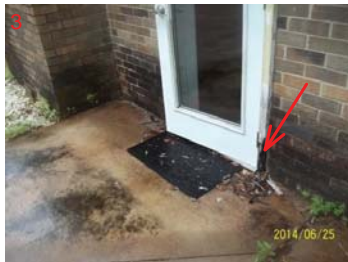
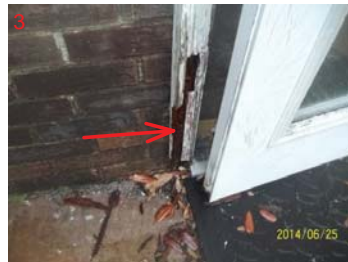
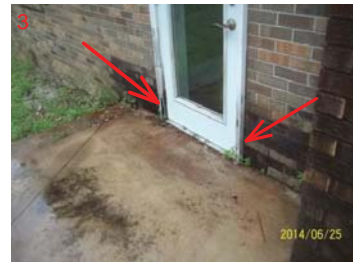
2. Trim: Wood 1. Wood rot in trim at front windows, suggest repair.
2. Trim removed at rear door frame, suggest replacement.
3. Wood rot/damage at all patio door frames, suggest repair.

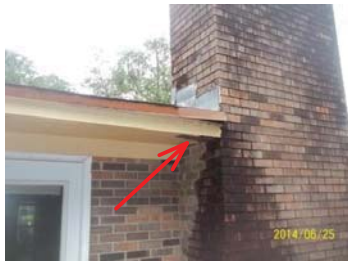
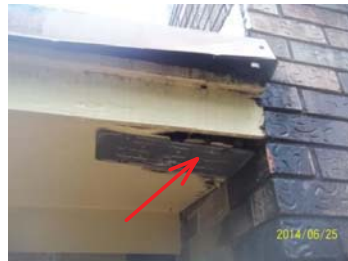
4. Soffits: Wood Wood rot in soffit at rear near chimney, suggest repair.

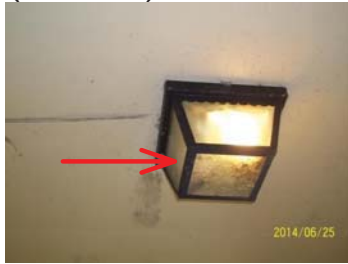
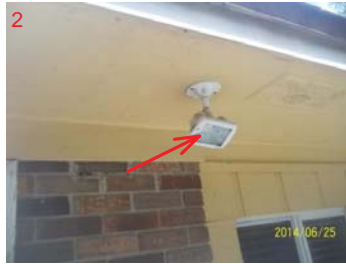
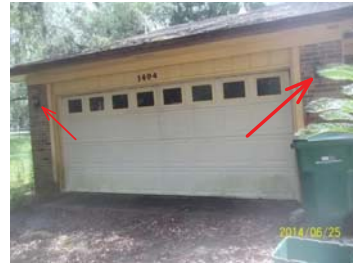
Exterior Lighting: (continued)

10. Exterior Lighting: Surface mount 1. One of two bulbs at Front entry did not illuminate when activated, suggest bulb replacement and re-test.
2. Exterior lights at rear did not illuminate when activated, suggest bulb replacement and re-test.
3. Exterior lights at garage did not illuminate when activated, suggest bulb replacement and re-test.

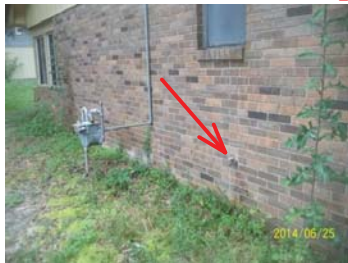
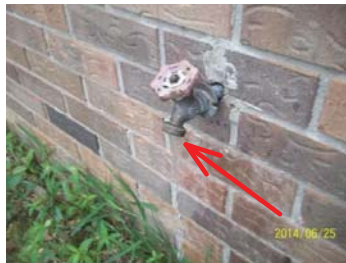
Hose Bibs: Rotary Hose bib at left side did not close completely and water ran during the inspection, suggest repair. Water turned off at the meter after inspection.

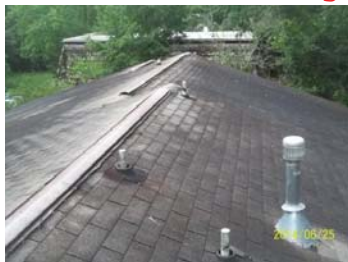
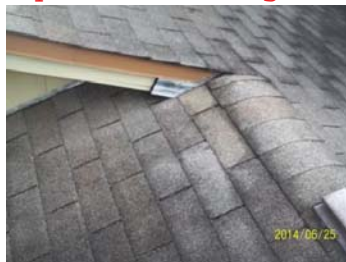
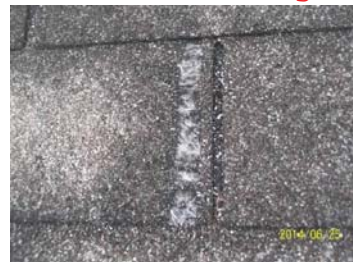
2. Material: Fiberglass shingle Aging noted at roof surfaces and evidence of water penetration and deterioration of the sheathing in the attic. This roof should be evaluated by a licensed roofing contractor to determine the integrity of the shingles and roof sheathing.

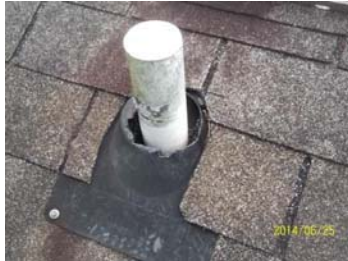
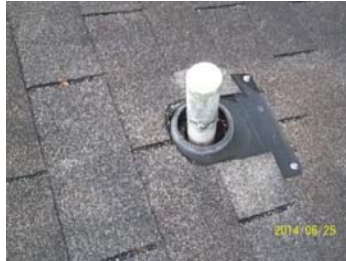
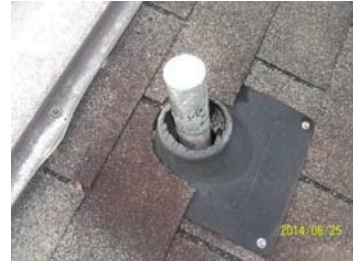
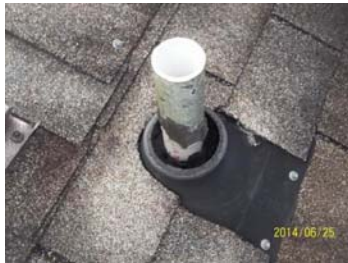
6. Plumbing Vents: PVC with Rubber Boots Damage/deterioration noted at all plumbing vent boots, suggest repair/replacement.

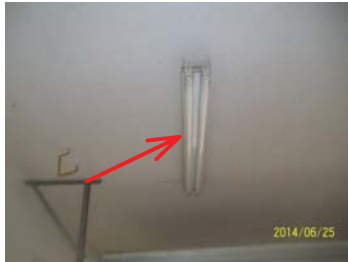
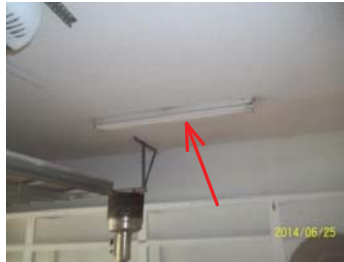
7. Walls: Sheetrock-Paint
8. Floor/Foundation: Poured concrete
9. Electrical: 110 VAC outlets and lighting circuits **Overhead lights did not illuminate, suggest bulb replacement and re-test.**

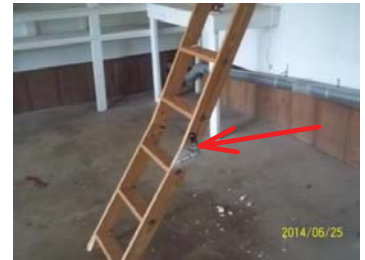
1. Method of Inspection: In the attic
2. Attic Access Drop-down Ladder Ladder unstable (over-extended at hinge) at attic access, suggest repair for safety.

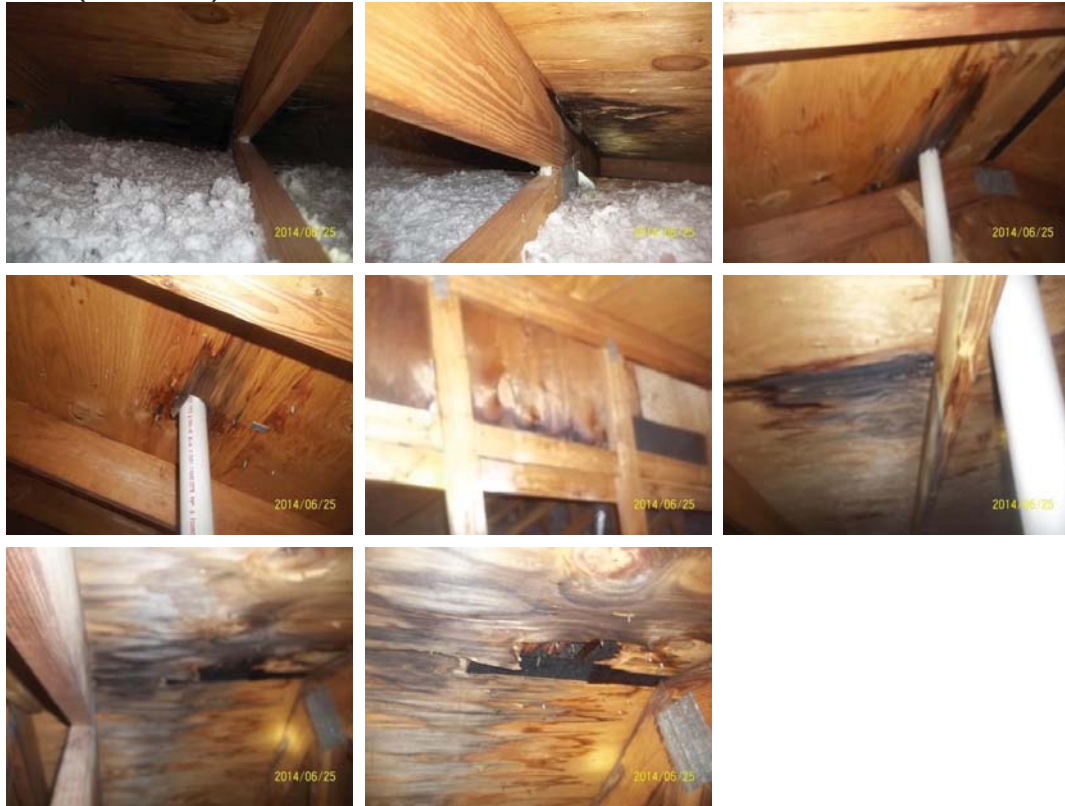
Moisture Penetration: (continued)

3. Unable to Inspect: 20% Framing, insulation and placement of HVAC equipment prevented full visual inspection.
4. Roof Framing: 2x4 Truss
5. Sheathing: Plywood
6. Ventilation: Ridge and soffit vents
7. Insulation: Loose
8. Insulation Depth: 10-12 inches
9. Wiring/Lighting: 110 VAC lighting circuit
10. Moisture Penetration: Ongoing water penetration noted Water staining and penetration at all vent penetrations, suggest repair/replacement of vent boots. See remarks at Roof-Plumbing Vents. Water staining at front center above garage. Water staining and sheathing damage at right side center (Near ridge), These areas should be evaluated by a Licensed roofing contractor to determine the integrity of the roofing system.

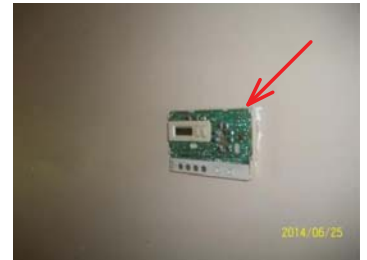
11. Electrical Disconnect: Breaker disconnect
12. Exposed Ductwork: Insulated flex
13. Blower Fan/Filters: Direct drive with disposable filter
14. Thermostats: Individual Cover for thermostat not present, suggest replacement. Thermostat operated properly during inspection.

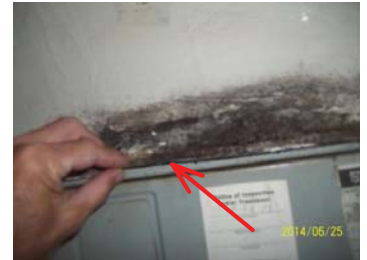
1. Heating System Operation: Not Operated Ambient temperature was above 70 degrees. System not operated to avoid potential damage to reversing valve.
2. Manufacturer: Trane
3. Model Number: TEV024B140A1 Serial Number: K27349094
4. Type: Heat Pump Capacity: N/A
5. Area Served: Entire Dwelling Approximate Age: 19 Years
6. Fuel Type: Electric
7. Blower Fan/Filter: Direct drive with disposable filter
8. Distribution: Insulflex duct **Loose connection at top of air handler, suggest sealing. Mildew growth at this location should be cleaned. Growth may be attributed to condensation caused by loose duct connection.**
9. Thermostats: Individual
10. Suspected Asbestos: No

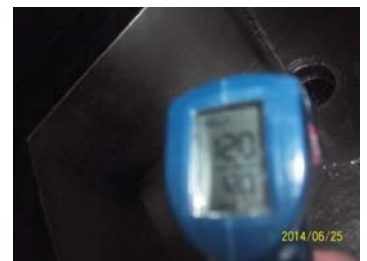
1. Service Line: Undetermined Service line not visible due to soil/sand accumulation at meter box.
 2. Main Water Shutoff: Meter
 3. Water Lines: Copper
 4. Drain Pipes: PVC
 5. Service Caps: Not visible
 6. Vent Pipes: PVC
 7. Gas Service Lines: Steel
- ### Garage Water Heater
8. Water Heater Operation: Functional at time of inspection Hot water measured 120 degrees at kitchen sink.

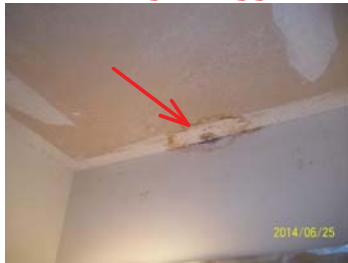
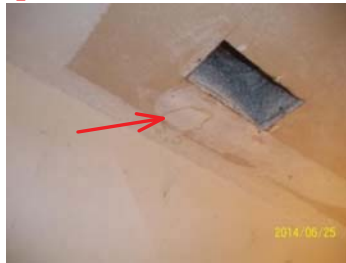
1. Ceiling: Sheetrock-Paint Water staining at ceiling and incomplete finishing, suggest repair. See remarks at Roof-Plumbing Vents.

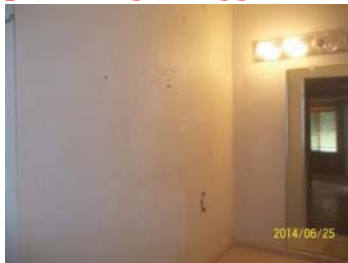
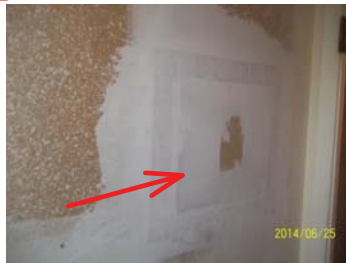
2. Walls: Sheetrock-Paint Wallpaper removed from walls and incomplete patching, suggest repair.

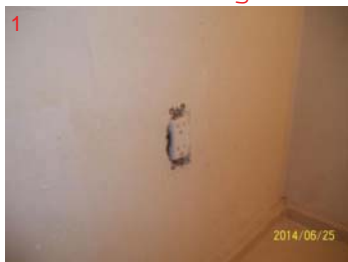
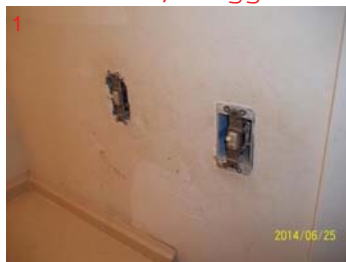
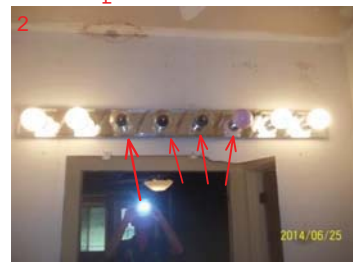
6. Electrical: 110 VAC outlets and lighting circuits 1. Cover plates not installed at walls, suggest replacement.
2. Not all lights illuminated, suggest bulb replacement and re-test.

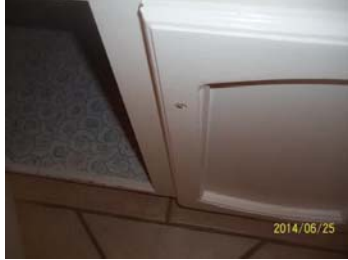
7. Counter/Cabinet: Fiberglass/Wood Door handles not present at cabinet, suggest replacement.

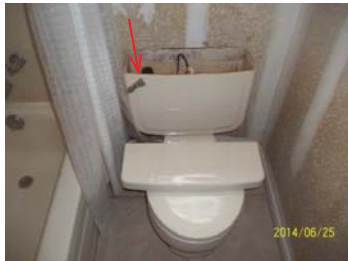
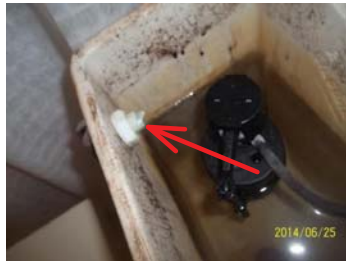
11. Shower/Surround: Over Tub
12. Toilets: Kilgore Flushing mechanism damaged/disconnected at handle, suggest adjustment/repair.

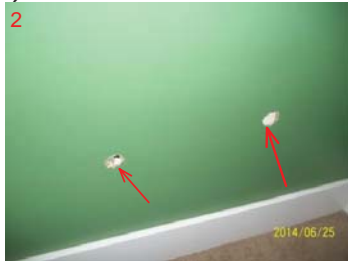
9. Closet: Single 1. Closet door removed from hardware (leaning against wall), suggest replacement.
2. Holes in closet wall, suggest repair.

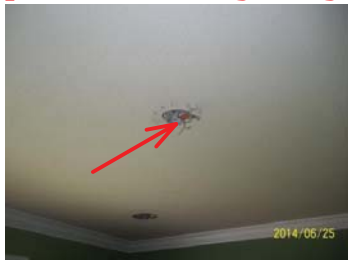
- 14. Windows: Metal Single/Double hung
- 15. Electrical: 110 VAC outlets and lighting circuits Fixture and bulbs not present at lighting, suggest replacement and re-test.

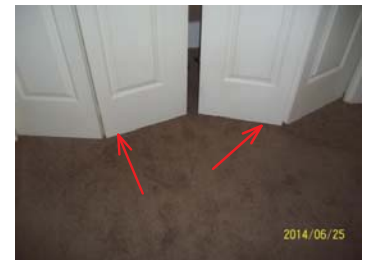
- 17. Closet: Single Closet doors rub at carpet, suggest adjustment/repair during routine maintenance.

4. Right Front Bedroom Closet: Single Closet doors rub at carpet, suggest adjustment/repair during routine maintenance.

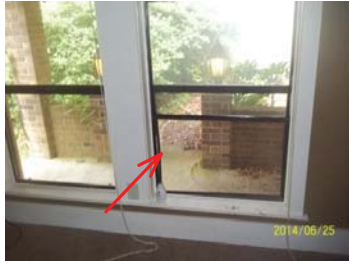
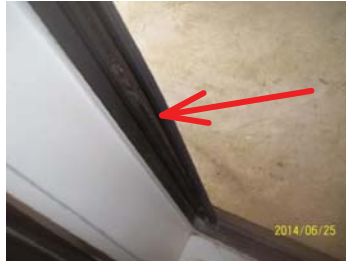
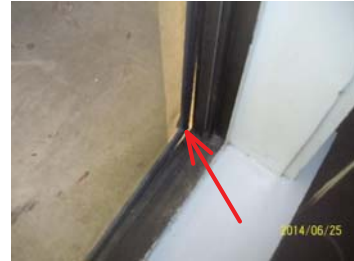
22. Windows: Metal Single/Double hung Window screen bent at right front window, suggest replacement.

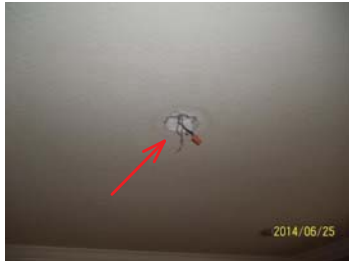
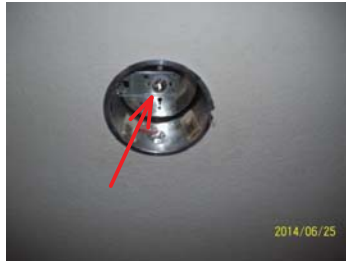
23. Electrical: 110 VAC outlets and lighting circuits Fixture and bulbs not present at lighting, suggest replacement and re-test.

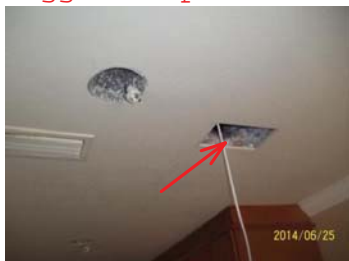
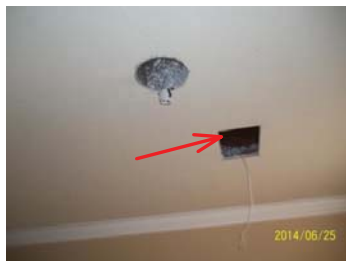
1. Ceiling: Sheetrock-Paint Holes in ceiling from removed sound system, suggest repair.

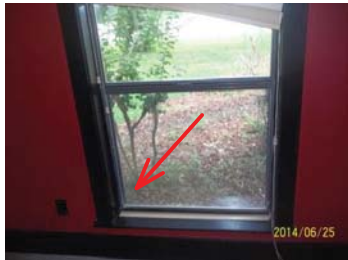
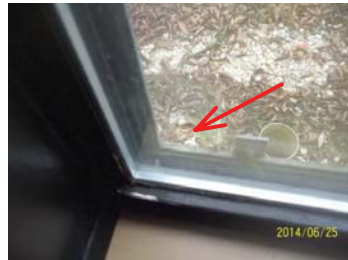
16. Windows: Metal Single/Double hung **Window screen damaged/not present at window, suggest replacement.**

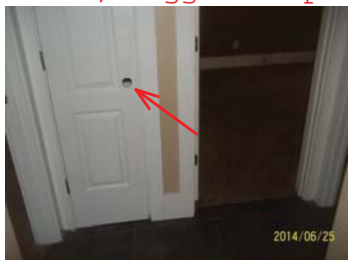
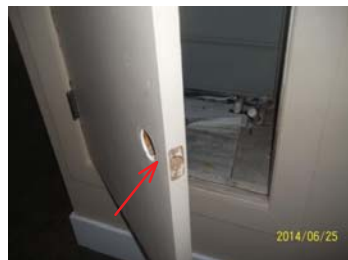
19. Closet: Linen & Utility **Hardware removed from linen and utility closet doors, suggest replacement.**

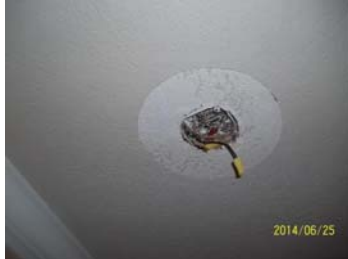
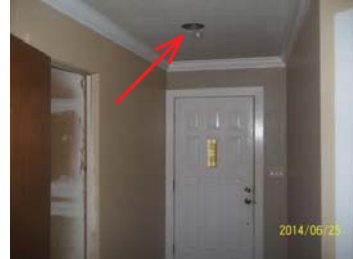
21. Walls: Sheetrock-Paint
 22. Floor: Tile
 23. Electrical: 110 VAC outlets and lighting circuits **Fixtures removed from hall and foyer ceilings, suggest replacement.**

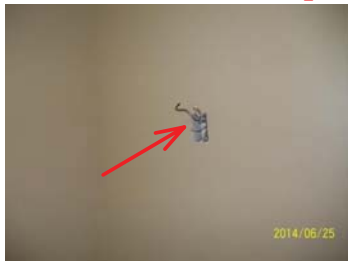
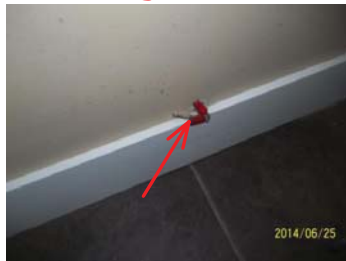
1. Ceiling: Sheetrock-Paint
 2. Walls: Sheetrock-Paint
 3. Floor: Tile
 4. Electrical: 110 VAC outlets and lighting circuits **Outlet removed from wall and exposed wires at ground level, suggest replacement of outlet and removal of exposed wiring.**

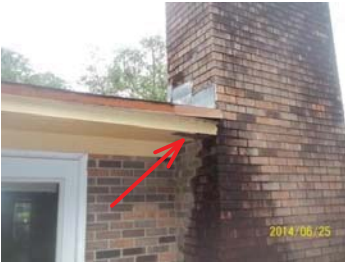
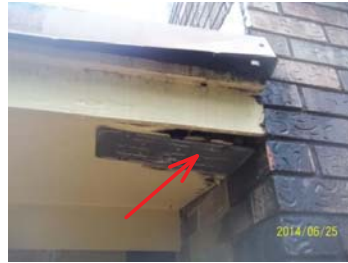
4. Soffits: Wood Wood rot in soffit at rear near chimney, suggest repair.

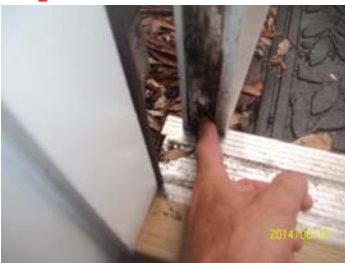
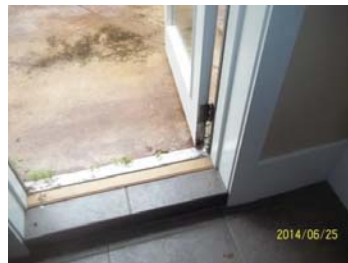
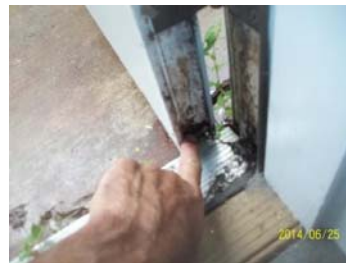
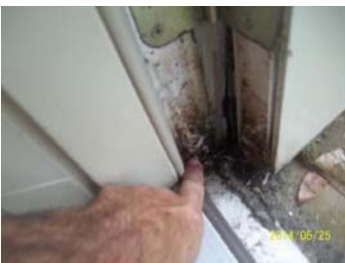
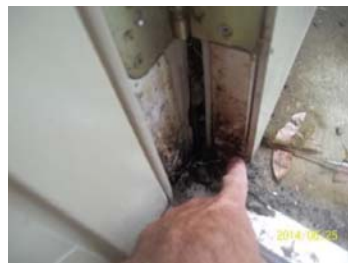
6. Patio Door: Vinyl/Glass Wood rot at the wooden core of all patio doors, suggest repair.

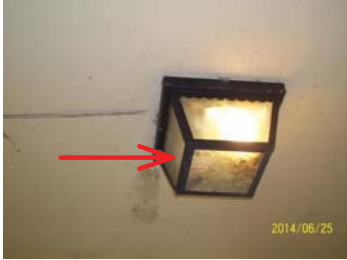
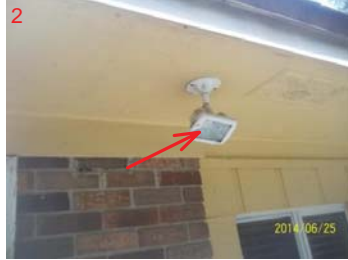
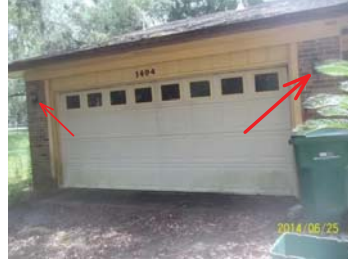
7. Exterior Lighting: Surface mount 1. One of two bulbs at Front entry did not illuminate when activated, suggest bulb replacement and re-test.
2. Exterior lights at rear did not illuminate when activated, suggest bulb replacement and re-test.
3. Exterior lights at garage did not illuminate when activated, suggest bulb

replacement and re-test.

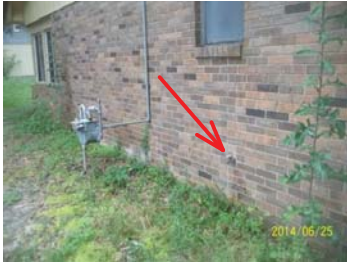
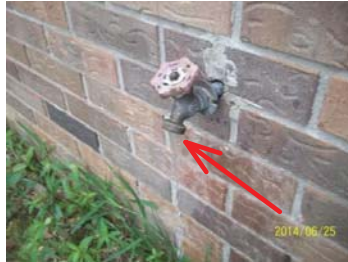
8. Hose Bibs: Rotary Hose bib at left side did not close completely and water ran during the inspection, suggest repair. Water turned off at the meter after inspection.

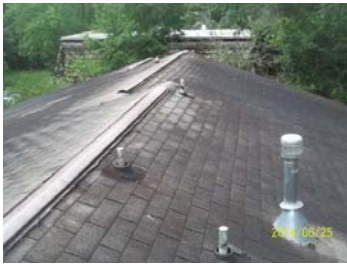
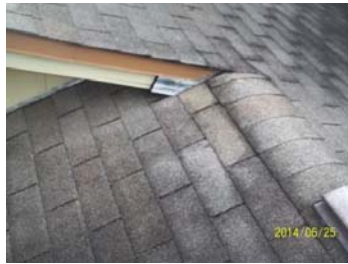
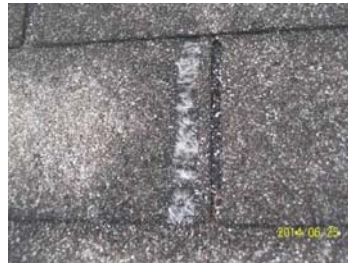
9. Main Roof Surface Material: Fiberglass shingle Aging noted at roof surfaces and evidence of water penetration and deterioration of the sheathing in the attic. This roof should be evaluated by a licensed roofing contractor to determine the integrity of the shingles and roof sheathing.

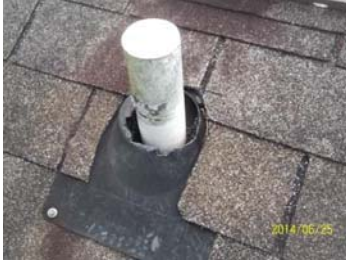
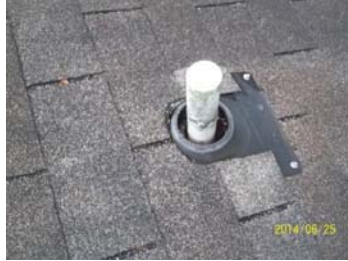
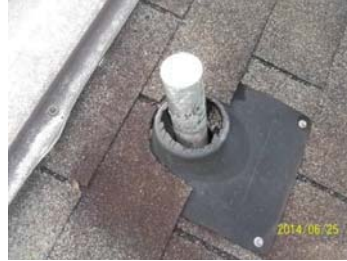
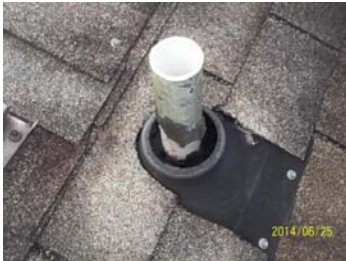
11. Plumbing Vents: PVC with Rubber Boots Damage/deterioration noted at all plumbing vent boots, suggest repair/replacement.

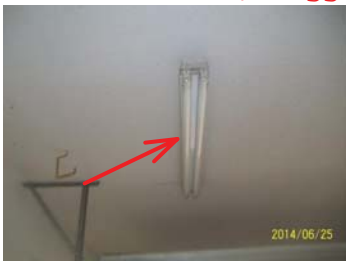
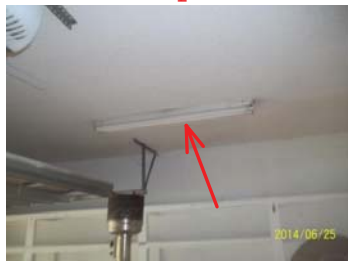
13. Front Left Garage Electrical: 110 VAC outlets and lighting circuits **Overhead lights did not illuminate, suggest bulb replacement and re-test.**

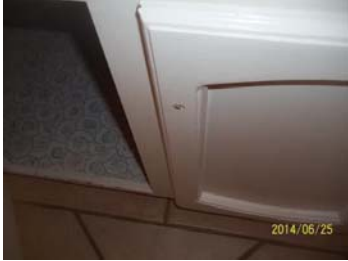
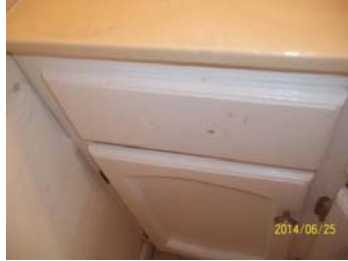
21. Master Bathroom Counter/Cabinet: Fiberglass/Wood Door handles not present at cabinet, suggest replacement.

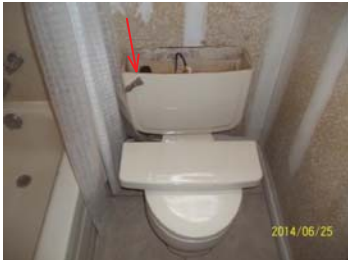
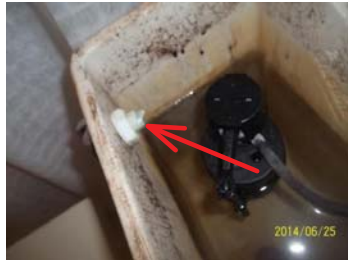
24. Master Bathroom Toilets: Kilgore Flushing mechanism damaged/disconnected at handle, suggest adjustment/repair.

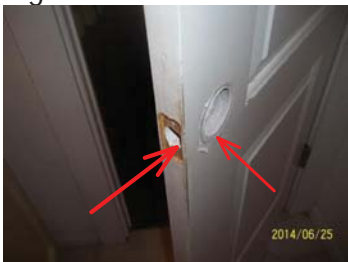
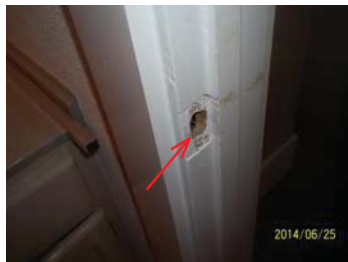
25. Right Hall Bathroom Doors: Standard Door hardware removed, suggest replacement.

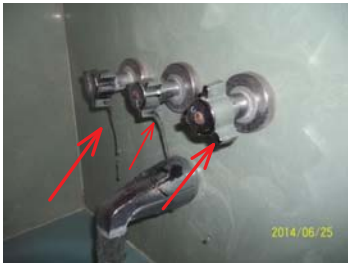
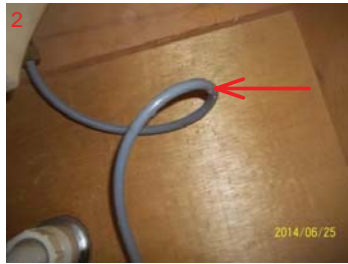
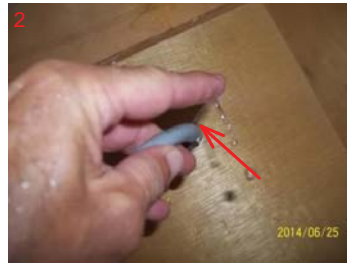
28. Right Hall Bathroom Faucets/Traps: Metal/PVC 1. Leak observed at all three tub faucet handles when in operation, suggest adjustment/repair.
2. Leak observed in supply line for the cold water side of sink, suggest repair. Water turned off at shut-off valve after detection.

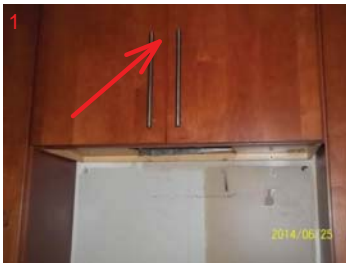
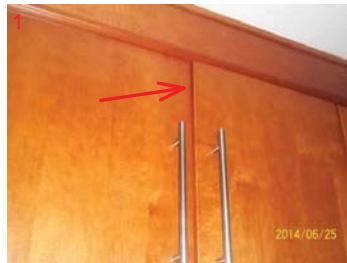
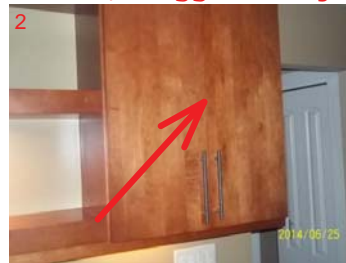
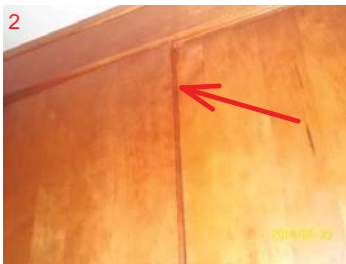
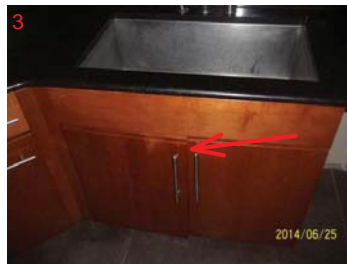
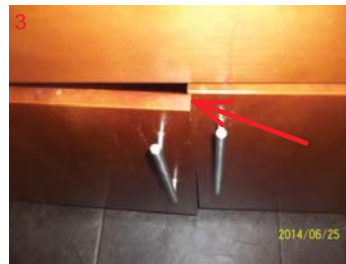
32. Main Kitchen Cabinets: Wood
1. Cupboard doors above microwave enclosure collide when closed, suggest adjustment/repair.
 2. Cupboard doors at right side collide when closed, suggest adjustment/repair.
 3. Cabinet doors under sink collide when closed, suggest adjustment/repair.

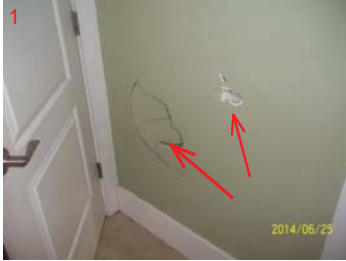
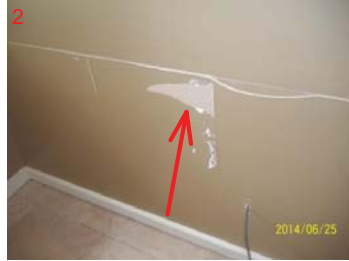
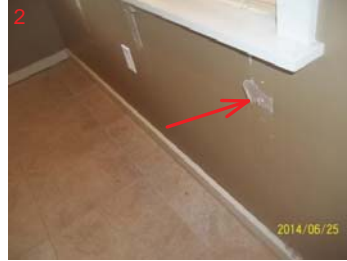
35. Master Bedroom Walls: Sheetrock-Paint
1. Holes in wall behind door, suggest repair.
 2. Peeling sheet-rock paper at rear area of bedroom, suggest repair.

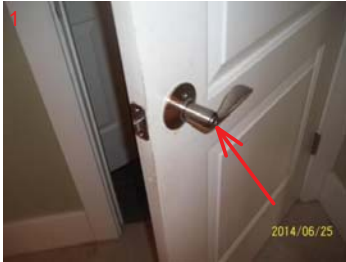
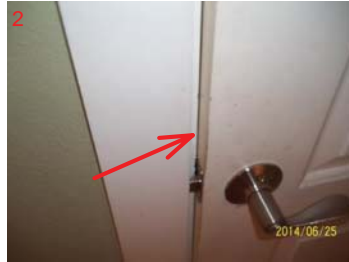
36. Master Bedroom Doors: Standard 1. Door lock non-functional, suggest repair/replacement.
2. Door collides with frame at closing, suggest adjustment/repair.

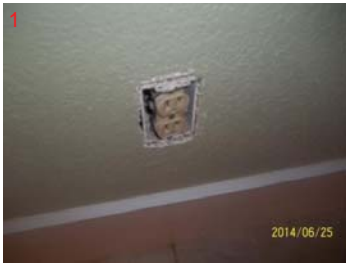
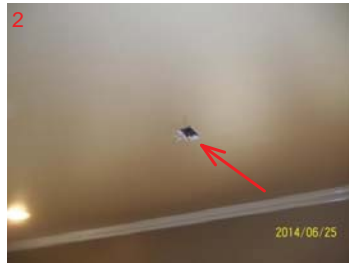
37. Master Bedroom Electrical: 110 VAC outlets and lighting circuits 1. Cover plate not installed at rear wall, suggest replacement.
2. Fixture removed from ceiling at rear area of bedroom, suggest replacement.

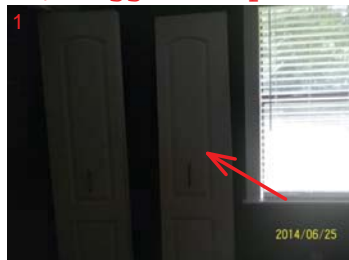
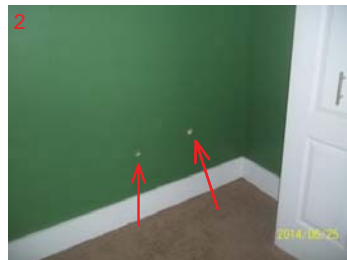
38. Right Rear Bedroom Closet: Single 1. Closet door removed from hardware (leaning against wall), suggest replacement.
2. Holes in closet wall, suggest repair.

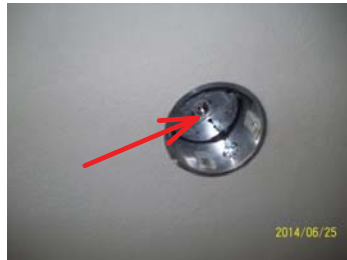
40. Right Rear Bedroom Electrical: 110 VAC outlets and lighting circuits Fixture and bulbs not present at lighting, suggest replacement and re-test.

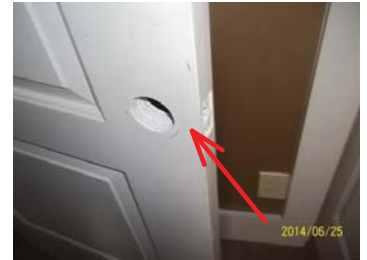
41. Right Front Bedroom Doors: Standard Hardware removed from door, suggest replacement.

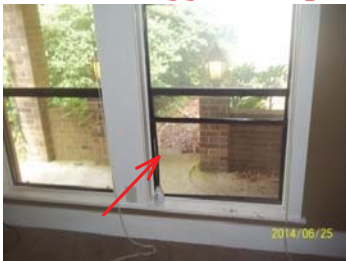
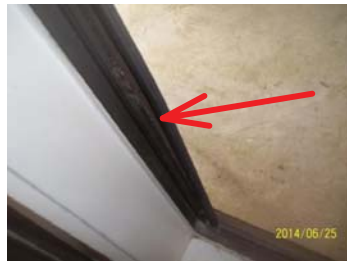
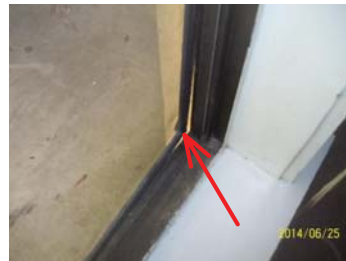
42. Right Front Bedroom Windows: Metal Single/Double hung Window screen bent at right front window, suggest replacement.

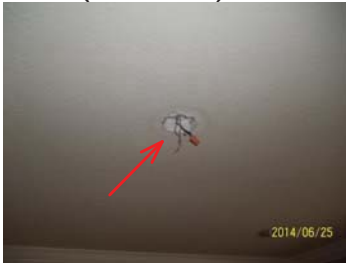
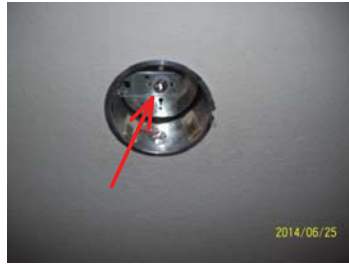
43. Right Front Bedroom Electrical: 110 VAC outlets and lighting circuits Fixture and bulbs not present at lighting, suggest replacement and re-test.

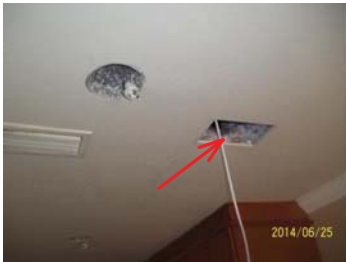
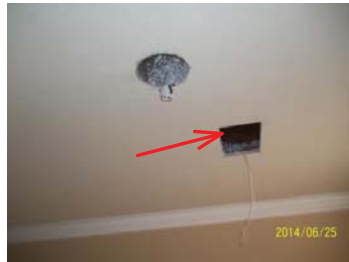
44. Living Room Living Space Ceiling: Sheetrock-Paint Holes in ceiling from removed sound system, suggest repair.

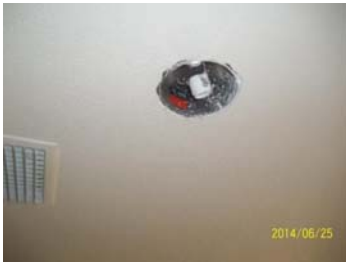
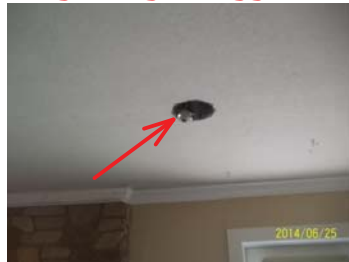
45. Living Room Living Space Electrical: 110 VAC outlets and lighting circuits Fixtures/bulbs removed from overhead lighting, suggest replacement.

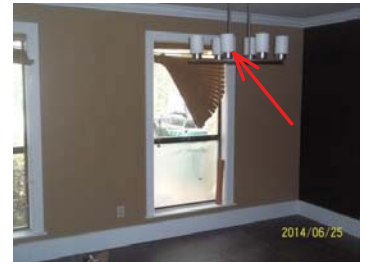
48. Dining Room Living Space Electrical: 110 VAC outlets and lighting circuits **No lights illuminated, bulb replacement and re-test indicated no electricity at this fixture, suggest further evaluation by qualified technician with repair as necessary.**

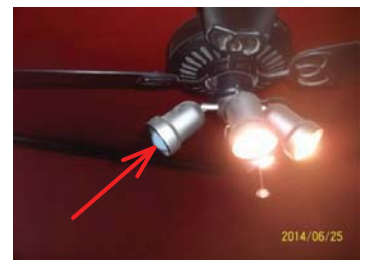
52. Office Area Living Space Electrical: 110 VAC outlets and lighting circuits **Not all lights illuminated, suggest bulb replacement and re-test.**

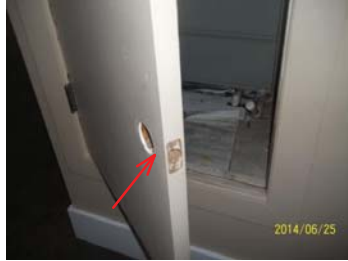
53. Foyer/Hallways Living Space Closet: Linen & Utility **Hardware removed from linen and utility closet doors, suggest replacement.**

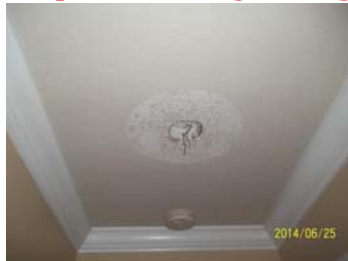
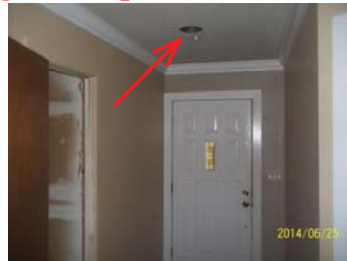
54. Foyer/Hallways Living Space Electrical: 110 VAC outlets and lighting circuits **Fixtures removed from hall and foyer ceilings, suggest replacement.**

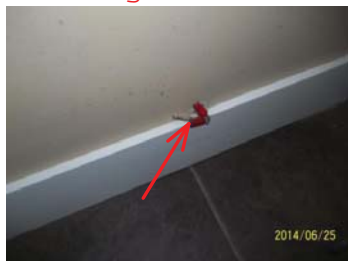
55. Off Garage Laundry Room/Area Electrical: 110 VAC outlets and lighting circuits **Outlet removed from wall and exposed wires at ground level, suggest replacement of outlet and removal of exposed wiring.**
